**DEPARTMENT OF TRANSPORTATION**

Contract #: 04-0120F4Cty: SF/ALA Rte: 80 PM: 13.2/13.9File #: 69.28**WELDING INSPECTION REPORT****Resident Engineer:** Siegenthaler, Peter**Address:** 333 Burma Road**City:** Oakland, CA 94607**Report No:** WIR-017838**Date Inspected:** 08-Nov-2010**Project Name:** SAS Superstructure**OSM Arrival Time:** 700**Prime Contractor:** American Bridge/Fluor Enterprises, a JV**OSM Departure Time:** 1900**Contractor:** Zhenhua Port Machinery Company, Ltd (ZPMC), Changxing Island **Location:** Shanghai, China**CWI Name:** Li Yang**CWI Present:** Yes No**Inspected CWI report:** Yes No N/A**Rod Oven in Use:** Yes No N/A**Electrode to specification:** Yes No N/A**Weld Procedures Followed:** Yes No N/A**Qualified Welders:** Yes No N/A**Verified Joint Fit-up:** Yes No N/A**Approved Drawings:** Yes No N/A**Approved WPS:** Yes No N/A**Delayed / Cancelled:** Yes No N/A**Bridge No:** 34-0006**Component:** OBG Segments**Summary of Items Observed:**

## WELDING INSPECTION REPORT

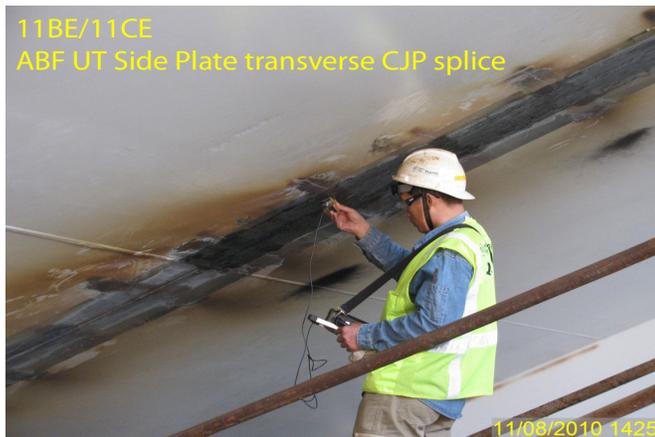
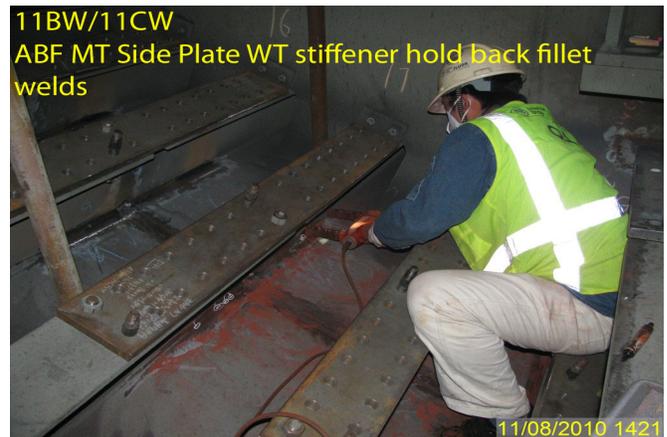
Unless otherwise noted, all work observed on this date appeared to generally comply with applicable contract documents.
