**DEPARTMENT OF TRANSPORTATION**

Contract #: 04-0120F4Cty: SF/ALA Rte: 80 PM: 13.2/13.9File #: 69.28**WELDING INSPECTION REPORT****Resident Engineer:** Siegenthaler, Peter**Address:** 333 Burma Road**City:** Oakland, CA 94607**Report No:** WIR-017861**Date Inspected:** 14-Oct-2010**Project Name:** SAS Superstructure**OSM Arrival Time:** 700**Prime Contractor:** American Bridge/Fluor Enterprises, a JV**OSM Departure Time:** 1900**Contractor:** Zhenhua Port Machinery Company, Ltd (ZPMC), Changxing Island **Location:** Shanghai, China**CWI Name:** Liu Hua Jie**CWI Present:** Yes No**Inspected CWI report:** Yes No N/A**Rod Oven in Use:** Yes No N/A**Electrode to specification:** Yes No N/A**Weld Procedures Followed:** Yes No N/A**Qualified Welders:** Yes No N/A**Verified Joint Fit-up:** Yes No N/A**Approved Drawings:** Yes No N/A**Approved WPS:** Yes No N/A**Delayed / Cancelled:** Yes No N/A**Bridge No:** 34-0006**Component:** Orthotropic Box Girder (OBG)**Summary of Items Observed:**

**OBG # TRIAL ASSEMBLY YARD**

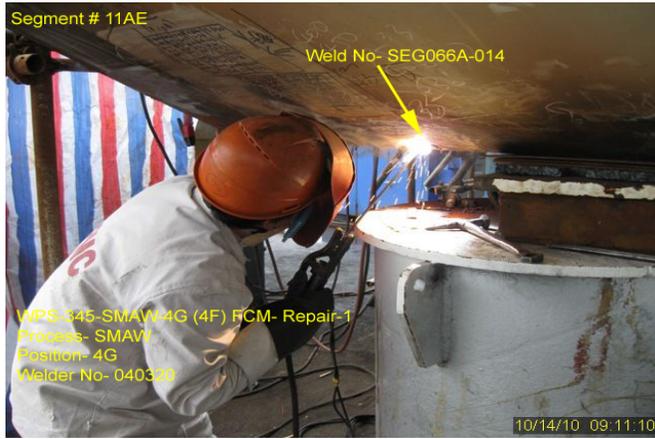
This QA inspector observed ZPMC qualified welding personnel identified as 040320 perform Shielded Metal Arc Welding (SMAW), weld joint identified as SEG066A-014; located On Orthotropic Box Girder (OBG) Bottom Plate to Side Plate Transverse CJP Weld. The Critical Welding Repair Report (CWRR) was B- CWR2044. ZPMC Quality Control (QC) is identified as Mr.Liu Hua Jie. The welding variables recorded by QC appeared to comply with the Applicable WPS-345-SMAW 4G (4F) FCM Repair-1 See the attached Photo.

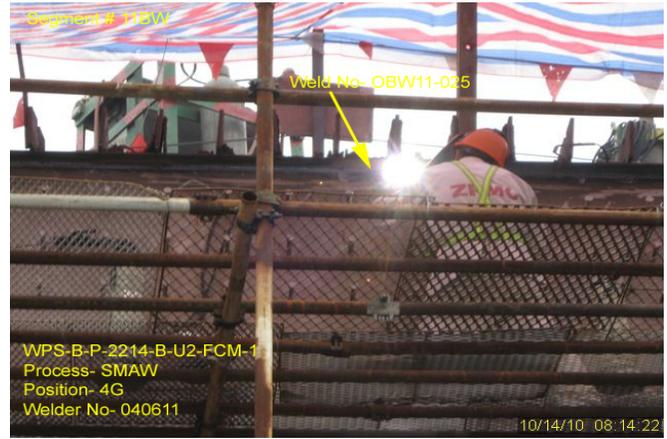
This QA inspector observed ZPMC qualified welding personnel identified as 040611 perform Shielded Metal Arc Welding (SMAW), weld joint identified as OBW11-025; located On Orthotropic Box Girder (OBG) Deck Plate to Counter Weight Connection Plate CJP joint. ZPMC Quality Control (QC) is identified as Mr. Wang Zhu. The welding variables recorded by QC appeared to comply with the Applicable WPS-B-P-2214-B-U2-FCM-1. See the attached Photo.
