DEPARTMENT OF TRANSPORTATION

Contract #: 04-0120F4Cty: SF/ALA Rte: 80 PM: 13.2/13.9File #: 1.28**WELDING INSPECTION REPORT****Resident Engineer:** Siegenthaler, Peter**Address:** 333 Burma Road**City:** Oakland, CA 94607**Report No:** WIR-017894**Date Inspected:** 03-Nov-2010**Project Name:** SAS Superstructure**OSM Arrival Time:** 1000**Prime Contractor:** American Bridge/Fluor Enterprises, a JV**OSM Departure Time:** 1830**Contractor:** American Bridge/Fluor Enterprises, a JV**Location:** Job Site

WELDING INSPECTION REPORT

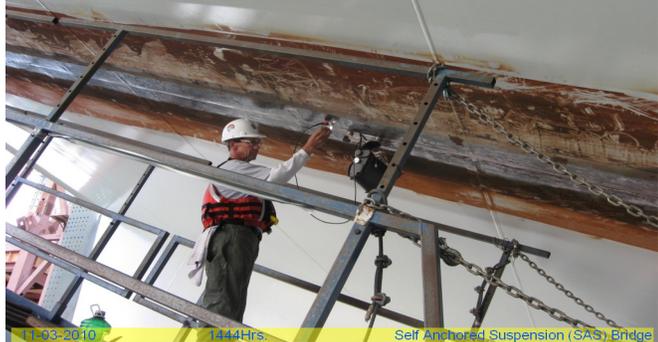
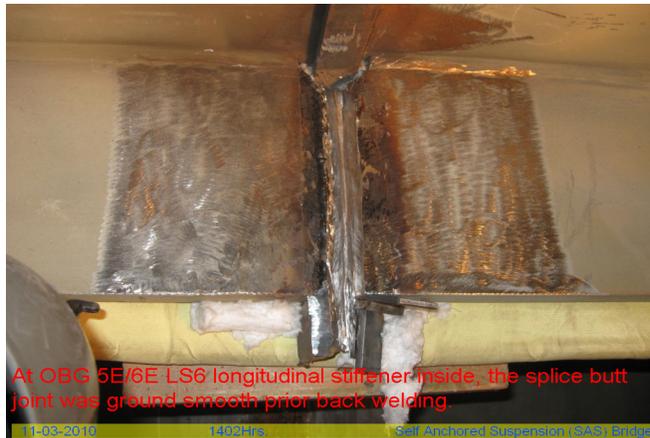
At OBG 6W/7W side plate 'E' outside, ABF QC Tom Pasqualone was observed performing Ultrasonic Testing (UT) on the flush ground cover of the back welded splice butt joint.
