DEPARTMENT OF TRANSPORTATION

Contract #: 04-0120F4Cty: SF/ALA Rte: 80 PM: 13.2/13.9File #: 1.28**WELDING INSPECTION REPORT****Resident Engineer:** Siegenthaler, Peter**Address:** 333 Burma Road**City:** Oakland, CA 94607**Report No:** WIR-017897**Date Inspected:** 05-Nov-2010**Project Name:** SAS Superstructure**OSM Arrival Time:** 630**Prime Contractor:** American Bridge/Fluor Enterprises, a JV**OSM Departure Time:** 1500**Contractor:** American Bridge/Fluor Enterprises, a JV**Location:** Job Site**CWI Name:** See below**CWI Present:** Yes No**Inspected CWI report:** Yes No N/A**Rod Oven in Use:** Yes No N/A**Electrode to specification:** Yes No N/A**Weld Procedures Followed:** Yes No N/A**Qualified Welders:** Yes No N/A**Verified Joint Fit-up:** Yes No N/A**Approved Drawings:** Yes No N/A**Approved WPS:** Yes No N/A**Delayed / Cancelled:** Yes No N/A**Bridge No:** 34-0006**Component:** SAS OBG**Summary of Items Observed:**

WELDING INSPECTION REPORT

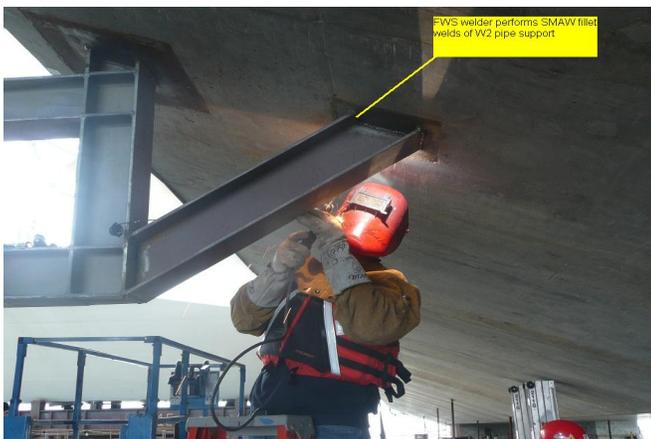
The QA Inspector arrived at W2 and observed the FWS Spencer welder identified as David Garcia performing the SMAW fillet welds attaching the pipe supports identified as PS-17 to the embed plates in the bridge. The QA Inspector randomly observed the approved welding quality control plan (WQCP) on site and noted the documentation appeared to be in general compliance with the contract requirements. The QA Inspector randomly observed the SE QC Inspector Tom Pagliero was on site and monitoring the in process welding. The QA Inspector randomly observed the SMAW parameters and they were 1/8" E7018 low hydrogen electrodes with 120 Amps the QA Inspector noted the SMAW parameters appeared to be in general compliance with the WPS identified as FWS Fillets Murex SFOBB. Upon the arrival of the QA Inspector it was observed the welding contractor had completed approximately 17 fillet welds. The QA Inspector noted the slag had not all been removed, but the size appeared to be in general compliance with the contract requirements.
