DEPARTMENT OF TRANSPORTATION

Contract #: 04-0120F4Cty: SF/ALA Rte: 80 PM: 13.2/13.9File #: 1.28**WELDING INSPECTION REPORT****Resident Engineer:** Siegenthaler, Peter**Address:** 333 Burma Road**City:** Oakland, CA 94607**Report No:** WIR-017898**Date Inspected:** 02-Nov-2010**Project Name:** SAS Superstructure**OSM Arrival Time:** 1000**Prime Contractor:** American Bridge/Fluor Enterprises, a JV**OSM Departure Time:** 1830**Contractor:** American Bridge/Fluor Enterprises, a JV**Location:** Job Site

WELDING INSPECTION REPORT

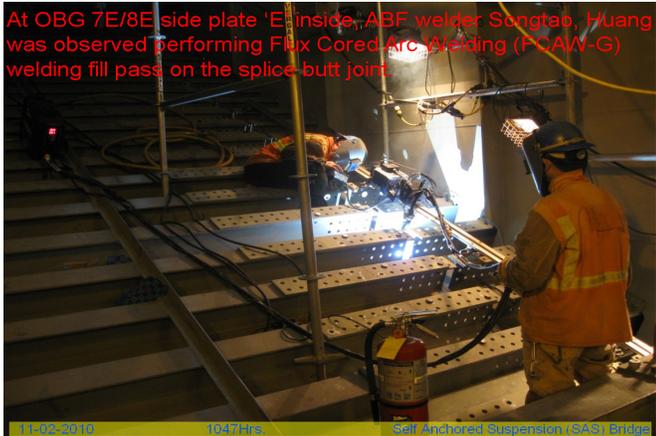
11-02-2010 10:47Hrs. Self Anchored Suspension (SAS) Bridge

At OBG 7E/8E side plate 'E' inside, ABF welder Songtao, Huang was observed performing Flux Cored Arc Welding (FCAW-G) welding fill pass on the splice butt joint.

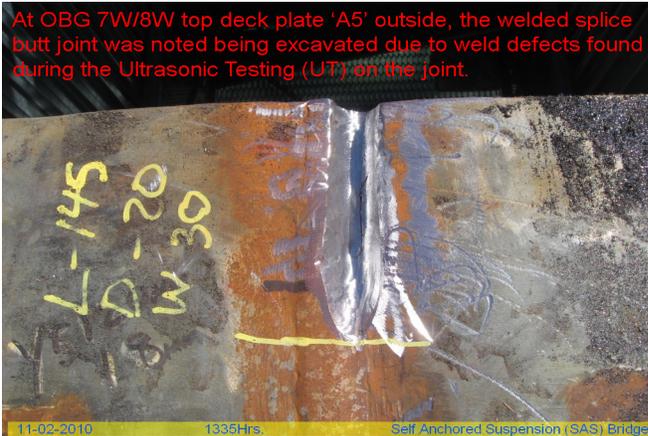
11-02-2010 13:35Hrs. Self Anchored Suspension (SAS) Bridge

At OBG 7W/8W top deck plate A5 outside, QA randomly observed ABF welder Fred Kaddu excavating two weld repairs. One repair was located at A5 with Y-dimension of 4170mm and was having 200mm long x 30mm wide x 20mm deep boat shape excavation profile. The other repair was located at A5 with Y-dimension of 5135mm and was having 145mm long x 30mm wide x 20mm deep excavation profile. After these two repairs were excavated, the welder has covered them with aluminum tape and left for another job. There was no welding performed on the two excavated repairs.

At OBG 7W/8W top deck plate 'A5' outside, the welded splice butt joint was noted being excavated due to weld defects found during the Ultrasonic Testing (UT) on the joint.

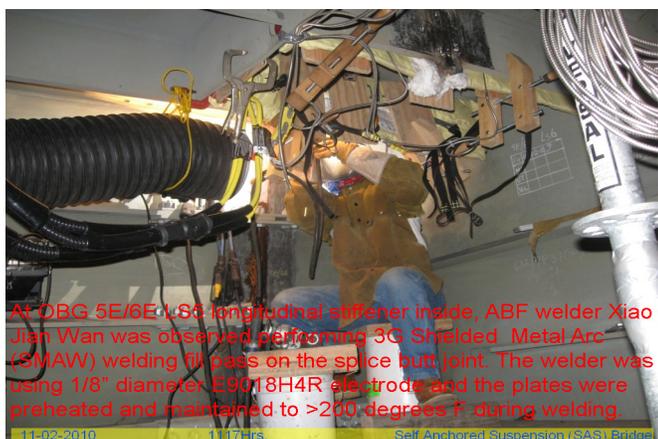
11-02-2010 11:17Hrs. Self Anchored Suspension (SAS) Bridge

At OBG 5E/6E 1/8" longitudinal stiffener inside, ABF welder Xiao Jian Wan was observed performing 3G Shielded Metal Arc (SMAW) welding fill pass on the splice butt joint. The welder was using 1/8" diameter E9018H4R electrode and the plates were preheated and maintained to >200 degrees F during welding.

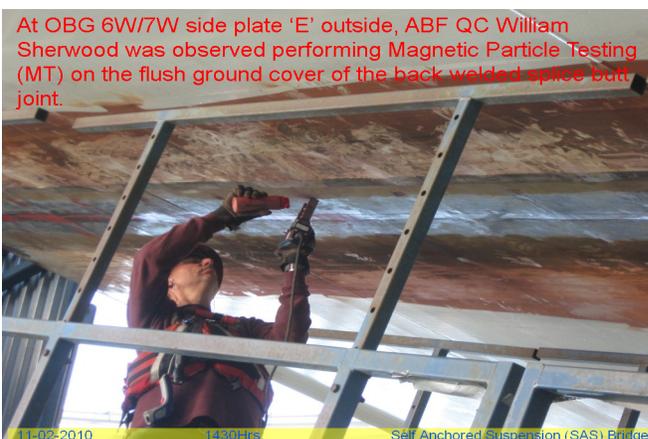
11-02-2010 14:50Hrs. Self Anchored Suspension (SAS) Bridge

At OBG 6W/7W side plate 'E' outside, ABF QC William Sherwood was observed performing Magnetic Particle Testing (MT) on the flush ground back weld reinforcement of the splice butt joint and ground temporary attachment removal areas. The ABF QC was using a Parker Contour Probe with red powder. At the end of the MT, QC informed QA that QC found no significant indications during the test.

At OBG 6W/7W side plate 'E' outside, ABF QC William Sherwood was observed performing Magnetic Particle Testing (MT) on the flush ground cover of the back welded splice butt joint.
