DEPARTMENT OF TRANSPORTATION

Contract #: 04-0120F4Cty: SF/ALA Rte: 80 PM: 13.2/13.9File #: 1.28**WELDING INSPECTION REPORT****Resident Engineer:** Siegenthaler, Peter**Address:** 333 Burma Road**City:** Oakland, CA 94607**Report No:** WIR-017899**Date Inspected:** 08-Nov-2010**Project Name:** SAS Superstructure**OSM Arrival Time:** 630**Prime Contractor:** American Bridge/Fluor Enterprises, a JV**OSM Departure Time:** 1500**Contractor:** American Bridge/Fluor Enterprises, a JV**Location:** Job Site**CWI Name:** See below**CWI Present:** Yes No**Inspected CWI report:** Yes No N/A**Rod Oven in Use:** Yes No N/A**Electrode to specification:** Yes No N/A**Weld Procedures Followed:** Yes No N/A**Qualified Welders:** Yes No N/A**Verified Joint Fit-up:** Yes No N/A**Approved Drawings:** Yes No N/A**Approved WPS:** Yes No N/A**Delayed / Cancelled:** Yes No N/A**Bridge No:** 34-0006**Component:** SAS OBG**Summary of Items Observed:**

WELDING INSPECTION REPORT

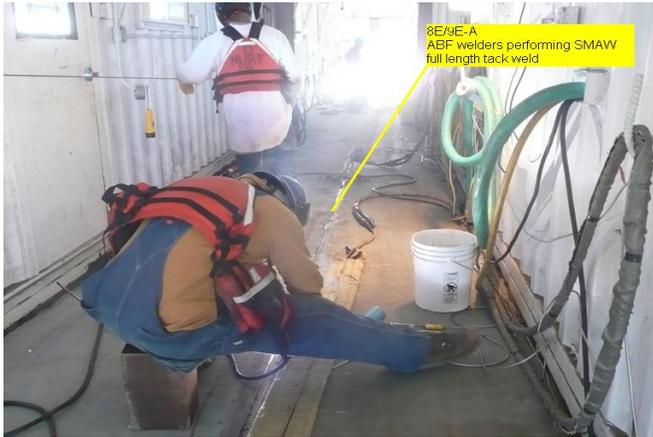
The QA Inspector randomly observed Earl Espinosa performing grinding tasks of ultrasonic testing rejects in the above identified lifting lug deck hole restorations. The QA Inspector randomly observed the ABF welder had previously excavated all of the UT rejections located in the above identified holes. The QA Inspector randomly observed the SE QC Inspector Pat Swain was on site to monitor and record the in process welding parameters. The QA Inspector noted the ABF welder was utilizing the shielded metal arc welding process with 5/32" E7018 low hydrogen electrodes. The QA Inspector randomly observed the ABF welder was utilizing 175 Amps while performing the SMAW repair. The QA Inspector performed a random visual inspection of the previously excavated areas and noted they had been ground and blended to a boat shaped weldable profile. The QA Inspector randomly observed and noted the ABF welder was preheating the material to approximately 100°F prior to making the SMAW repairs. The QA Inspector noted the SMAW repairs appeared to be in general compliance with ABF-WPS-1001 repair. The QA Inspector noted the repair welding was completed on the QA Inspectors shift. After the ABF welder completed the welding, he performed grinding tasks while removing the weld reinforcement flush with the top deck base material.
