DEPARTMENT OF TRANSPORTATION

Quality Assurance and Source Inspection

Contract #: 04-0120F4Cty: SF/ALA Rte: 80 PM: 13.2/13.9File #: 1.28**WELDING INSPECTION REPORT****Resident Engineer:** Siegenthaler, Peter**Address:** 333 Burma Road**City:** Oakland, CA 94607**Report No:** WIR-017903**Date Inspected:** 05-Nov-2010**Project Name:** SAS Superstructure**OSM Arrival Time:** 900**Prime Contractor:** American Bridge/Fluor Enterprises, a JV**OSM Departure Time:** 1730**Contractor:** American Bridge/Fluor Enterprises, a JV**Location:** Jobsite**CWI Name:** See below**CWI Present:** Yes No**Inspected CWI report:** Yes No N/A**Rod Oven in Use:** Yes No N/A**Electrode to specification:** Yes No N/A**Weld Procedures Followed:** Yes No N/A**Qualified Welders:** Yes No N/A**Verified Joint Fit-up:** Yes No N/A**Approved Drawings:** Yes No N/A**Approved WPS:** Yes No N/A**Delayed / Cancelled:** Yes No N/A**Bridge No:** 34-0006**Component:** SAS OBG**Summary of Items Observed:**

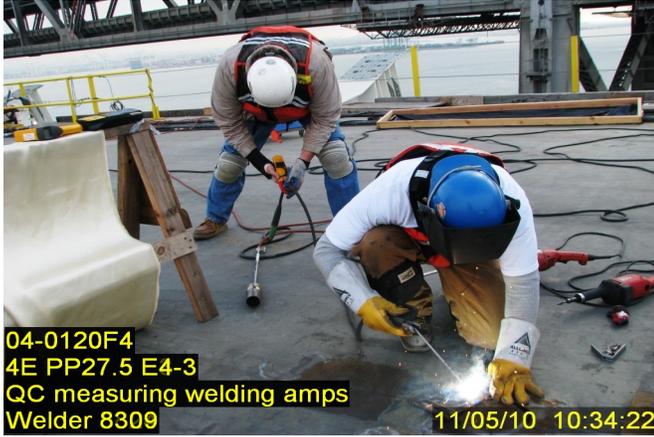
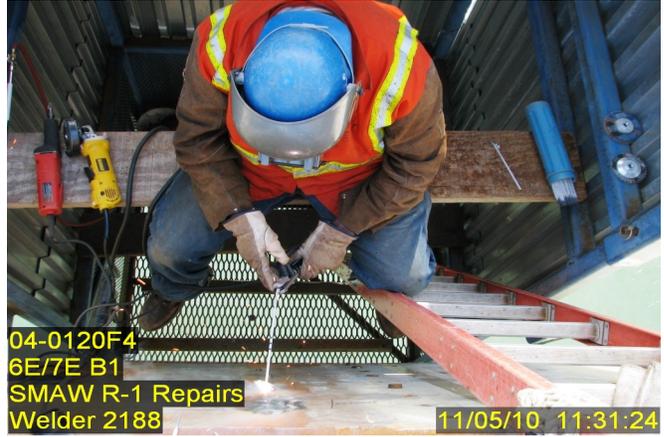
3). OBG Field Splice 6E/7E Weld ID: B1, Face A – (SMAW R-1 Repairs)

The QAI periodically observed AB/F approved welder Fred Kaddu (ID 2188) performing grinding to prepare R-1 Ultrasonic Testing (UT) repair locations and subsequently performing welding per the Shielded Metal Arc Welding (SMAW) process in the 3G (vertical) position of OBG Field Splice 6E/7E Weld ID: B1. See photo below. QC Inspector Steve McConnell was present to monitor the progress and verify that the welding parameters were within the limits established by the approved welding Procedure Specification (WPS) identified as ABF-WPS-D1.5-1001 Repair. Mr. McConnell also performed Magnetic Particle Testing (MT) of the excavated areas prior to the repair welding. The QAI observed that the performance and evaluation of the MT appeared to comply with the MT procedure identified as SE-MT-CT-D1.5-101 Rev. 4. The QAI observed that Mr. Kaddu completed welding of (4) four excavations with the following dimensions at the following Y locations:

Indication 1) - Y = 220mm, Length = 135mm, Depth = 16mm and Width = 25mm,

Indication 2) - Y = 505mm, Length = 165mm, Depth = 12mm and Width = 20mm.

Indication 3) - Y = 810mm, Length = 100mm, Depth = 19mm and Width = 25mm

Indication 4) - Y = 1040mm, Length = 100mm, Depth = 14mm and Width = 20mm

The QAI observed that work at these locations appeared to be in general compliance with contract documents.
