**DEPARTMENT OF TRANSPORTATION**

Contract #: 04-0120F4Cty: SF/ALA Rte: 80 PM: 13.2/13.9File #: 1.28**WELDING INSPECTION REPORT****Resident Engineer:** Siegenthaler, Peter**Address:** 333 Burma Road**City:** Oakland, CA 94607**Report No:** WIR-017908**Date Inspected:** 09-Nov-2010**Project Name:** SAS Superstructure**OSM Arrival Time:** 630**Prime Contractor:** American Bridge/Fluor Enterprises, a JV**OSM Departure Time:** 1500**Contractor:** American Bridge/Fluor Enterprises, a JV**Location:** Job Site**CWI Name:** See Below**CWI Present:** Yes No**Inspected CWI report:** Yes No N/A**Rod Oven in Use:** Yes No N/A**Electrode to specification:** Yes No N/A**Weld Procedures Followed:** Yes No N/A**Qualified Welders:** Yes No N/A**Verified Joint Fit-up:** Yes No N/A**Approved Drawings:** Yes No N/A**Approved WPS:** Yes No N/A**Delayed / Cancelled:** Yes No N/A**Bridge No:** 34-0006**Component:** Orthotropic Box Girders**Summary of Items Observed:**

## WELDING INSPECTION REPORT

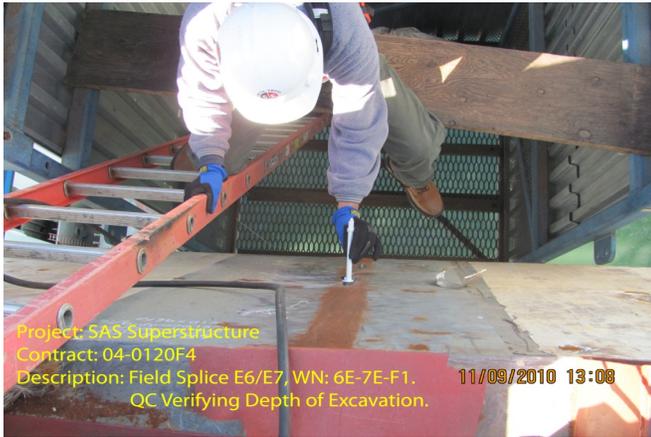
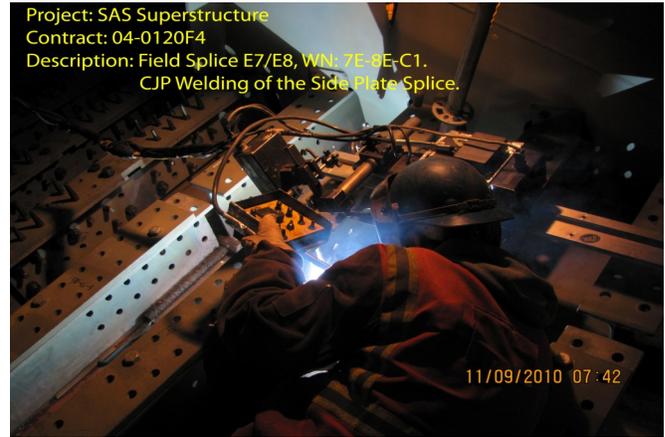
The digital photographs below illustrate the work observed during this scheduled shift.
