**DEPARTMENT OF TRANSPORTATION**

Contract #: 04-0120F4Cty: SF/ALA Rte: 80 PM: 13.2/13.9File #: 99.28**WELDING INSPECTION REPORT****Resident Engineer:** Siegenthaler, Peter**Address:** 333 Burma Road**City:** Oakland, CA 94607**Report No:** WIR-017931**Date Inspected:** 09-Nov-2010**Project Name:** SAS Superstructure**OSM Arrival Time:** 700**Prime Contractor:** American Bridge/Fluor Enterprises, a JV**OSM Departure Time:** 1900**Contractor:** Zhenhua Port Machinery Company, Ltd (ZPMC)**Location:** Shanghai, China

<b>CWI Name:</b>	N/A	<b>CWI Present:</b>	Yes	No
<b>Inspected CWI report:</b>	Yes No N/A	<b>Rod Oven in Use:</b>	Yes No N/A	
<b>Electrode to specification:</b>	Yes No N/A	<b>Weld Procedures Followed:</b>	Yes No N/A	
<b>Qualified Welders:</b>	Yes No N/A	<b>Verified Joint Fit-up:</b>	Yes No N/A	
<b>Approved Drawings:</b>	Yes No N/A	<b>Approved WPS:</b>	Yes No N/A	
		<b>Delayed / Cancelled:</b>	Yes No N/A	
<b>Bridge No:</b>	34-0006	<b>Component:</b>	OBG Trial Assembly

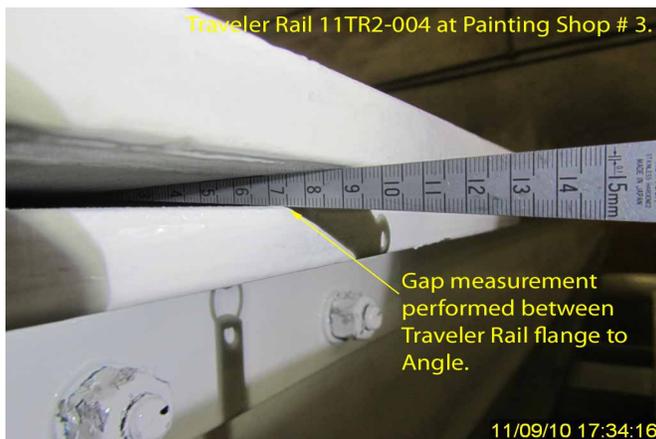
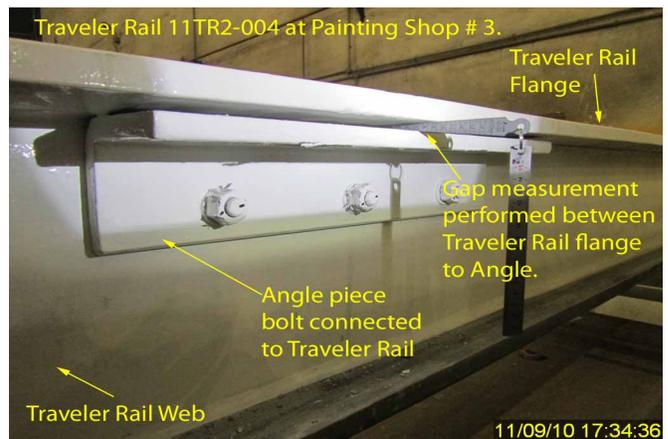
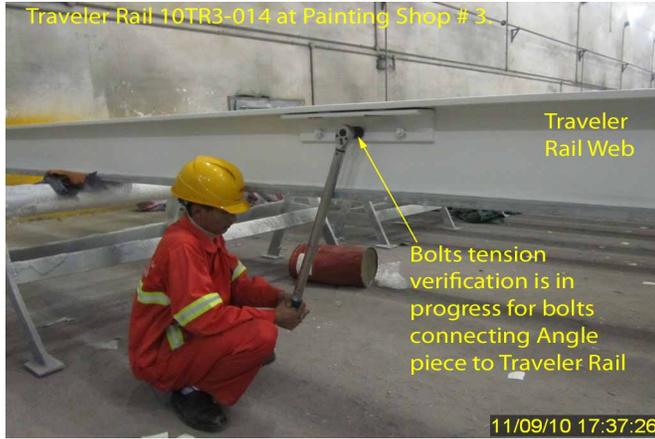
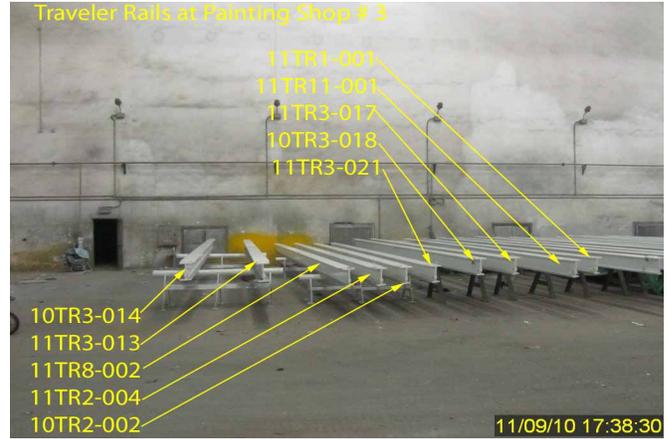
This QA Inspector witnessed the final bolt tension verification on bolts connecting the Traveler Rail at paint shop # 3. The QA Inspector verified the bolt tension for bolts connecting the Angle to Traveler Rail web on a random basis and the results appeared to be in general compliance. The Inspection was performed against Notification No. 00546 dated November 09, 2010.

Note: The QA Inspector measured the gap between the Angle to Traveler Rail flange and submitted the report to SMR for review and disposition.

The QA Inspector measured the Flatness using 1(One) Meter Straight Edge and the results appeared to be in general compliance with contract requirements.
