**DEPARTMENT OF TRANSPORTATION**

Contract #: 04-0120F4Cty: SF/ALA Rte: 80 PM: 13.2/13.9File #: 99.28**WELDING INSPECTION REPORT****Resident Engineer:** Siegenthaler, Peter**Address:** 333 Burma Road**City:** Oakland, CA 94607**Report No:** WIR-017955**Date Inspected:** 11-Oct-2010**Project Name:** SAS Superstructure**OSM Arrival Time:** 700**Prime Contractor:** American Bridge/Fluor Enterprises, a JV**OSM Departure Time:** 1900**Contractor:** Zhenhua Port Machinery Company, Ltd (ZPMC) Chanxing Island**Location:** Shanghai, China**CWI Name:** Mr. Xu Tao**CWI Present:** Yes No**Inspected CWI report:** Yes No N/A**Rod Oven in Use:** Yes No N/A**Electrode to specification:** Yes No N/A**Weld Procedures Followed:** Yes No N/A**Qualified Welders:** Yes No N/A**Verified Joint Fit-up:** Yes No N/A**Approved Drawings:** Yes No N/A**Approved WPS:** Yes No N/A**Delayed / Cancelled:** Yes No N/A**Bridge No:** 34-0006**Component:** OBG Bike Path**Summary of Items Observed:**

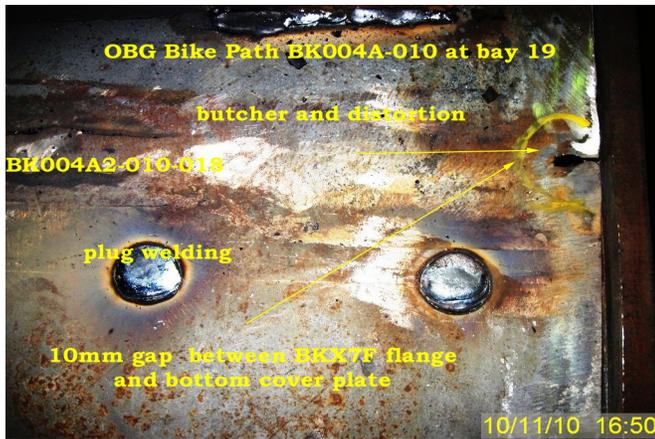
Description of Incident: During the Quality Assurance random work in progress and visual inspection (VT) review of weld located on OBG Bike Path BK004A-010 at Fabrication bay 19, this Quality Assurance Inspector (QA) observed that Bike Path bottom cover plate bended and butchered. And this QA Inspector measured the gap approximately 10mm between BKX7F flange and bottom cover plate. This butcher and distortion appeared to be caused by mishandling and fit up error during the bike path assembly. The butchered weld number is identified as BK004A2-010-018. ZPMC personnel performed plug welding over the bottom cover plates. The welder is identified as 208781. ZPMC QC known about these problem and ZPMC QC is identified as Mr. Xu Tao. See the
