DEPARTMENT OF TRANSPORTATION

Contract #: 04-0120F4Cty: SF/ALA Rte: 80 PM: 13.2/13.9File #: 99.28**WELDING INSPECTION REPORT****Resident Engineer:** Siegenthaler, Peter**Address:** 333 Burma Road**City:** Oakland, CA 94607**Report No:** WIR-017968**Date Inspected:** 26-Oct-2010**Project Name:** SAS Superstructure**OSM Arrival Time:** 700**Prime Contractor:** American Bridge/Fluor Enterprises, a JV**OSM Departure Time:** 1900**Contractor:** Zhenhua Port Machinery Company, Ltd (ZPMC) Chanxing Island**Location:** Shanghai, China**CWI Name:** Mr. Xu Tao**CWI Present:** Yes No**Inspected CWI report:** Yes No N/A**Rod Oven in Use:** Yes No N/A**Electrode to specification:** Yes No N/A**Weld Procedures Followed:** Yes No N/A**Qualified Welders:** Yes No N/A**Verified Joint Fit-up:** Yes No N/A**Approved Drawings:** Yes No N/A**Approved WPS:** Yes No N/A**Delayed / Cancelled:** Yes No N/A**Bridge No:** 34-0006**Component:** OBG Segment and Bike Path**Summary of Items Observed:**

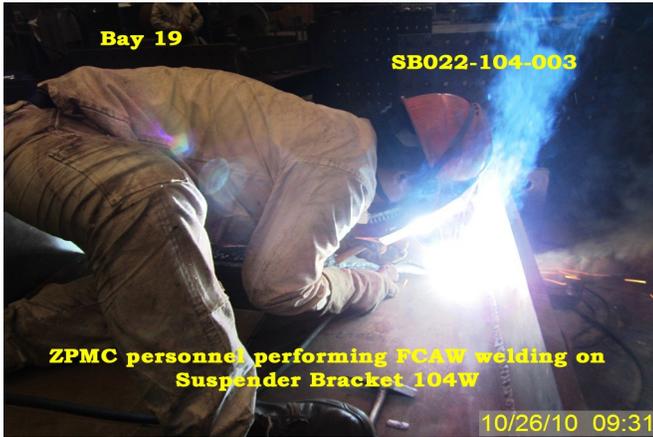
Unless otherwise noted, all work observed on this date appeared to be in general compliance with the applicable contract documents.
