DEPARTMENT OF TRANSPORTATION

Quality Assurance and Source Inspection

Contract #: 04-0120F4Cty: SF/ALA Rte: 80 PM: 13.2/13.9File #: 69.28**WELDING INSPECTION REPORT****Resident Engineer:** Siegenthaler, Peter**Address:** 333 Burma Road**City:** Oakland, CA 94607**Report No:** WIR-018018**Date Inspected:** 18-Oct-2010**Project Name:** SAS Superstructure**OSM Arrival Time:** 700**Prime Contractor:** American Bridge/Fluor Enterprises, a JV**OSM Departure Time:** 1900**Contractor:** Zhenhua Port Machinery Company, Ltd (ZPMC), Changxing Island **Location:** Shanghai, China**CWI Name:** Mr. Li zhi jiang**CWI Present:** Yes No**Inspected CWI report:** Yes No N/A**Rod Oven in Use:** Yes No N/A**Electrode to specification:** Yes No N/A**Weld Procedures Followed:** Yes No N/A**Qualified Welders:** Yes No N/A**Verified Joint Fit-up:** Yes No N/A**Approved Drawings:** Yes No N/A**Approved WPS:** Yes No N/A**Delayed / Cancelled:** Yes No N/A**Bridge No:** 34-0006**Component:** Orthotropic Box Girder (OBG)**Summary of Items Observed:**

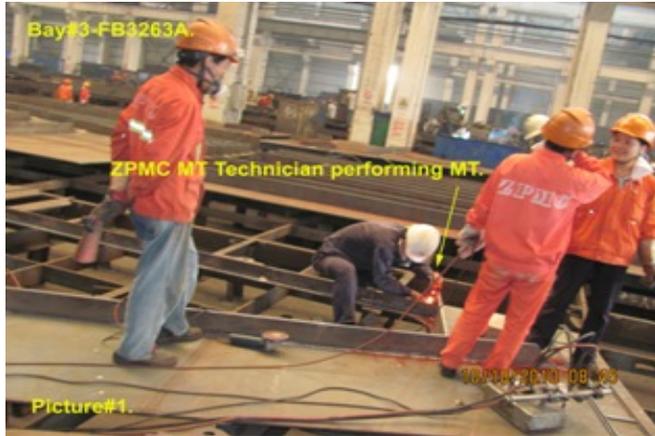
ZPMC MT Technician performing Magnetic Particle Testing for the welds located on Floor beam FB3263A. Refer the attached picture#1 for reference.

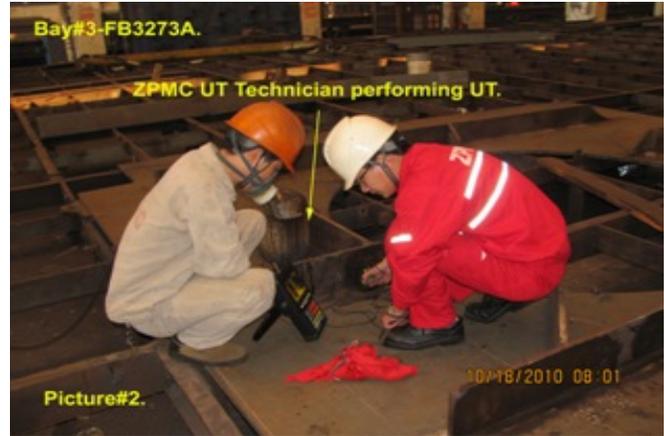
ZPMC UT Technician performing UT for the welds located on Floor beam FB3273A. Refer the attached picture#2 for reference.

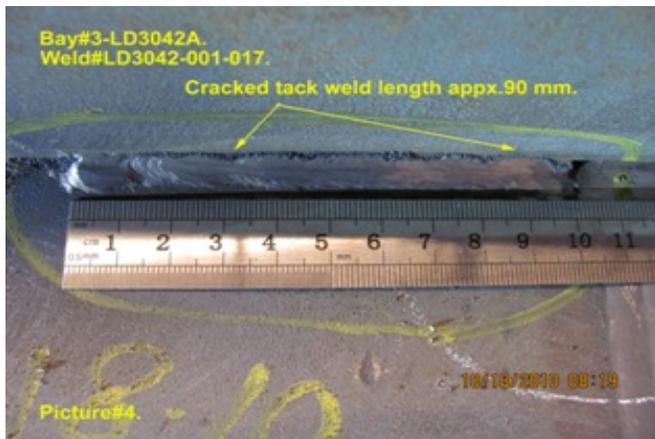
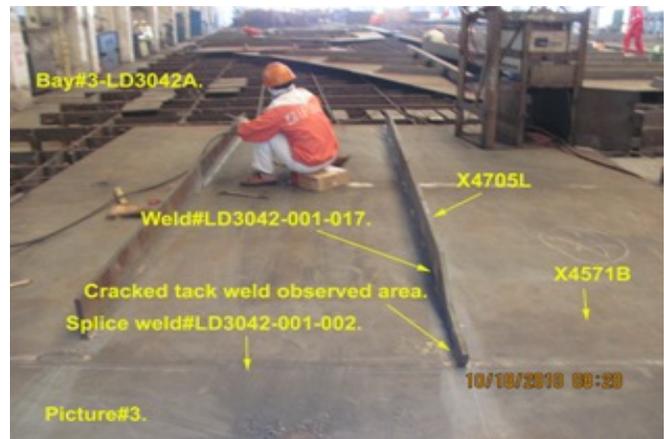
During random in process inspection of OBG member identified as Longitudinal diaphragm LD3042A, this QA observed a cracked tack weld on weld joint identified as LD3042-001-017. The “Y” location is 0 from the splice weld identified as LD3042-001-002. This QA marked the cracked tack and informed ZPMC Quality Control (QC) identified as Mr. Zhan Hai Feng of this issue. Mr. Zhan Hai Feng informed this QA that the cracked tack would be corrected in a manner compliant with the contract documents. Refer the attached picture # 3 and 4 for reference.
