**DEPARTMENT OF TRANSPORTATION**

Contract #: 04-0120F4Cty: SF/ALA Rte: 80 PM: 13.2/13.9File #: 69.28**WELDING INSPECTION REPORT****Resident Engineer:** Siegenthaler, Peter**Address:** 333 Burma Road**City:** Oakland, CA 94607**Report No:** WIR-018038**Date Inspected:** 29-Sep-2010**Project Name:** SAS Superstructure**OSM Arrival Time:** 700**Prime Contractor:** American Bridge/Fluor Enterprises, a JV**OSM Departure Time:** 1900**Contractor:** Zhenhua Port Machinery Company, Ltd (ZPMC), Changxing Island **Location:** Shanghai, China**CWI Name:** Wang Jie**CWI Present:** Yes No**Inspected CWI report:** Yes No N/A**Rod Oven in Use:** Yes No N/A**Electrode to specification:** Yes No N/A**Weld Procedures Followed:** Yes No N/A**Qualified Welders:** Yes No N/A**Verified Joint Fit-up:** Yes No N/A**Approved Drawings:** Yes No N/A**Approved WPS:** Yes No N/A**Delayed / Cancelled:** Yes No N/A**Bridge No:** 34-0006**Component:** OBG**Summary of Items Observed:**

# WELDING INSPECTION REPORT

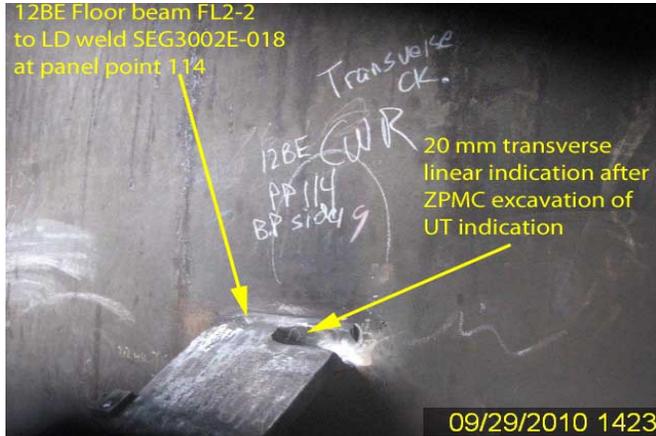
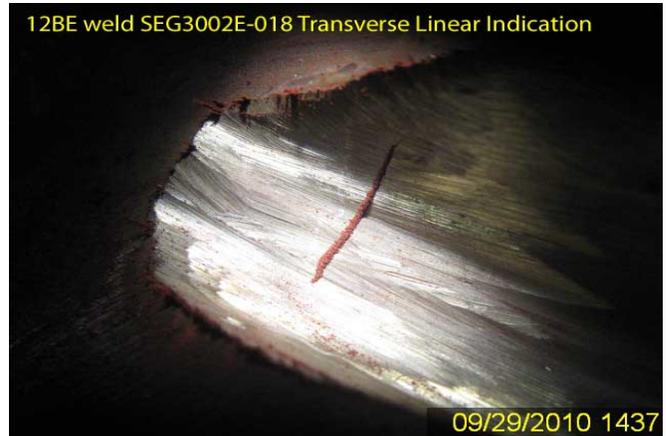
This QA Inspector observed a transverse crack measuring 20mm in length in FL2-2 Floor beam to Longitudinal Diaphragm weld, SEG3003E-018 after ZPMC personnel excavated longitudinal linear indication found by ZPMC Ultrasonic Testing technicians as per ZPMC weld repair report WR 15764. QA observed a transverse linear indication in the excavation area measuring 20mm in length. The indication was shown to ZPMC QC Li Yan Hua. Mr. Ping stated that a Critical Weld Repair report would be submitted to Caltrans Engineering for approval prior to removing the indication. See attached photo below for additional information.
