DEPARTMENT OF TRANSPORTATION

Office of Structural Materials

Contract #: 04-0120F4Cty: SF/ALA Rte: 80 PM: 13.2/13.9File #: 99.28**WELDING INSPECTION REPORT****Resident Engineer:** Siegenthaler, Peter**Address:** 333 Burma Road**City:** Oakland, CA 94607**Report No:** WIR-018080**Date Inspected:** 12-Nov-2010**Project Name:** SAS Superstructure**OSM Arrival Time:** 700**Prime Contractor:** American Bridge/Fluor Enterprises, a JV**OSM Departure Time:** 1900**Contractor:** Zhenhua Port Machinery Company, Ltd (ZPMC)**Location:** Shanghai, China**CWI Name:** Li Yang and Zhu Zhong Hai**CWI Present:** Yes No**Inspected CWI report:** Yes No N/A**Rod Oven in Use:** Yes No N/A**Electrode to specification:** Yes No N/A**Weld Procedures Followed:** Yes No N/A**Qualified Welders:** Yes No N/A**Verified Joint Fit-up:** Yes No N/A**Approved Drawings:** Yes No N/A**Approved WPS:** Yes No N/A**Delayed / Cancelled:** Yes No N/A**Bridge No:** 34-0006**Component:** OBG Trial Assembly**Summary of Items Observed:**

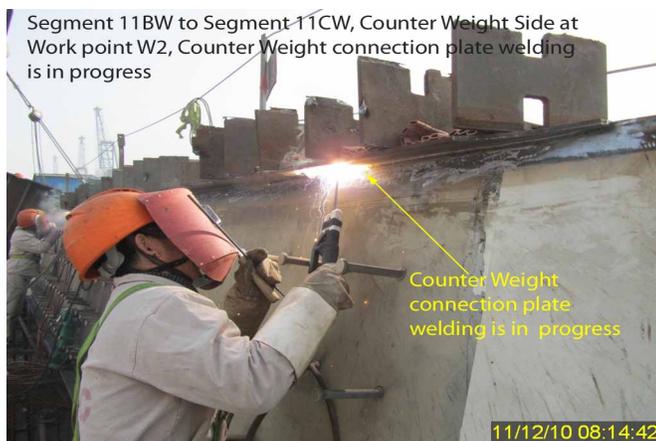
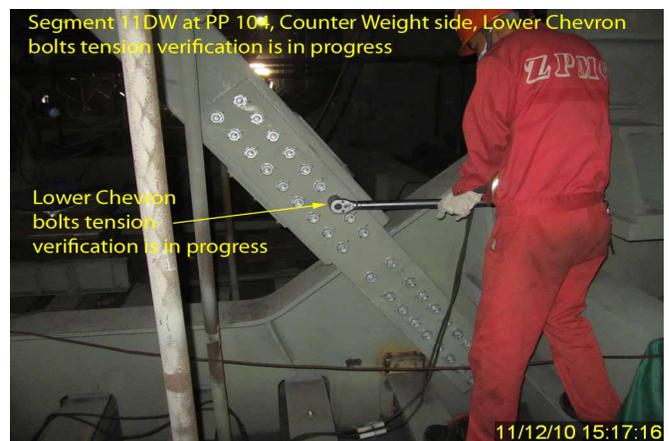
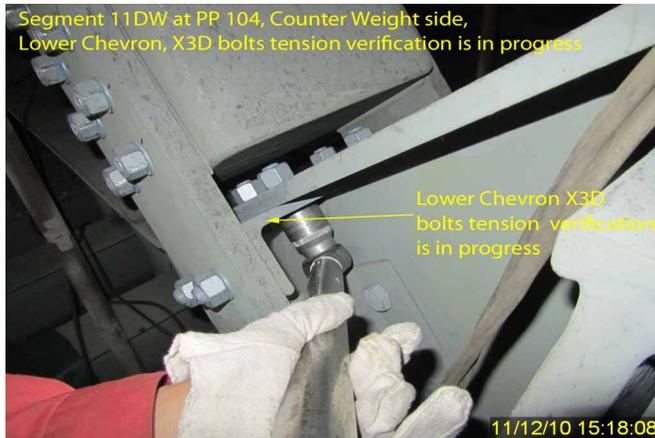
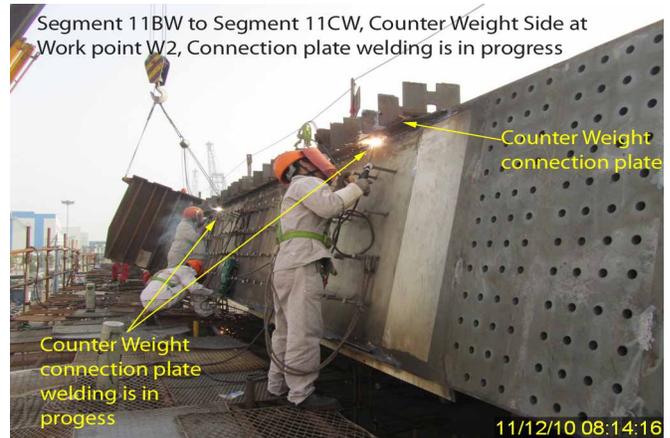
This Quality Assurance (QA) Inspector witnessed final bolt tension verification for Lower Chevron, Upper Chevron, X3D Bracket connected to floor beam flange and to the splice plate and H-Beam connecting the floor beam and splice plate at Panel Point (PP) 104, PP 105 and PP 106 for Segment 11DW at Counter Weight and Cross Beam side. Inspected 10% on a random basis and found the tension to be in general compliance. Inspection was performed against the Notification No. 00548 Dated November 12, 2010.

This QA Inspector observed the in-process welding by Shielded Metal Arc Welding (SMAW) process on a Complete Joint Penetration (CJP) groove weld. The Weld joint was designated as OBW11-027. The welder identification was 067183, 057333 and 041713 and was observed welding in the 4G (Overhead) position using approved Welding Procedure Specification WPS-B-P-2214-Tc-U4b-FCM-1. The piece mark was identified as the Counter Weight connection plate at work point W2.
