DEPARTMENT OF TRANSPORTATION

Quality Assurance and Source Inspection

Contract #: 04-0120F4Cty: SF/ALA Rte: 80 PM: 13.2/13.9File #: 69.28**WELDING INSPECTION REPORT****Resident Engineer:** Siegenthaler, Peter**Address:** 333 Burma Road**City:** Oakland, CA 94607**Report No:** WIR-018091**Date Inspected:** 03-Nov-2010**Project Name:** SAS Superstructure**OSM Arrival Time:** 700**Prime Contractor:** American Bridge/Fluor Enterprises, a JV**OSM Departure Time:** 1900**Contractor:** Zhenhua Port Machinery Company, Ltd (ZPMC), Changxing Island **Location:** Shanghai, China**CWI Name:** Qiu Wen**CWI Present:** Yes No**Inspected CWI report:** Yes No N/A**Rod Oven in Use:** Yes No N/A**Electrode to specification:** Yes No N/A**Weld Procedures Followed:** Yes No N/A**Qualified Welders:** Yes No N/A**Verified Joint Fit-up:** Yes No N/A**Approved Drawings:** Yes No N/A**Approved WPS:** Yes No N/A**Delayed / Cancelled:** Yes No N/A**Bridge No:** 34-0006**Component:** TOWER & OBG Components**Summary of Items Observed:**

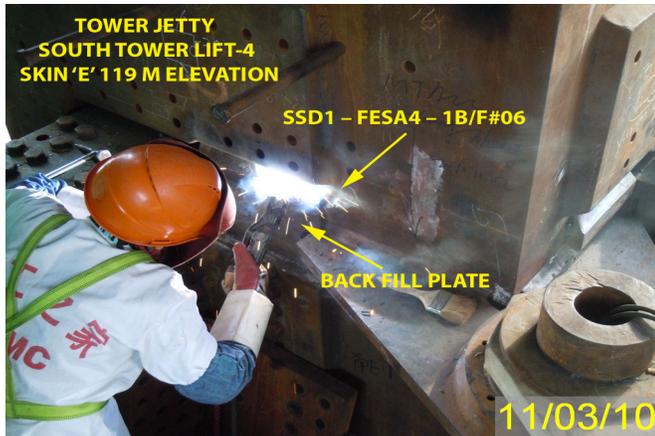
Weld joint # 06 located on South tower Lift-4 Skin 'E', 119 M Backfill plate SSD1 – FESA4 – 1B/F. Welder is identified as 040581. ZPMC Quality Control (QC) Inspector is identified Zhong Bei. The welding variables recorded by QC appeared to comply with the WPS – B – P – 3212 – B – U2a – 2.

(See attached photo)

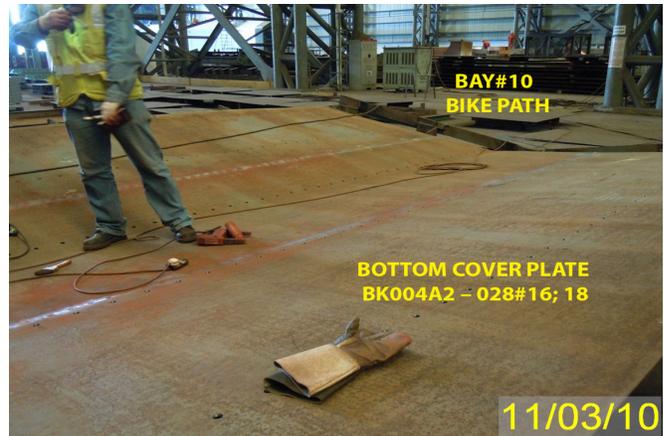
This QA inspector Witnessed 100% MT performed by ABF Quality Control personnel. The member is identified as OBG Component. The component designation is identified as follows:

BIKE PATH : BK004A2 – 028 – 016; 018

(See attached photo)
