DEPARTMENT OF TRANSPORTATION

Quality Assurance and Source Inspection

Contract #: 04-0120F4Cty: SF/ALA Rte: 80 PM: 13.2/13.9File #: 69.28**WELDING INSPECTION REPORT****Resident Engineer:** Siegenthaler, Peter**Address:** 333 Burma Road**City:** Oakland, CA 94607**Report No:** WIR-018107**Date Inspected:** 11-Nov-2010**Project Name:** SAS Superstructure**OSM Arrival Time:** 700**Prime Contractor:** American Bridge/Fluor Enterprises, a JV**OSM Departure Time:** 1900**Contractor:** Zhenhua Port Machinery Company, Ltd (ZPMC), Changxing Island **Location:** Shanghai, China**CWI Name:** Ye Yong Jun**CWI Present:** Yes No**Inspected CWI report:** Yes No N/A**Rod Oven in Use:** Yes No N/A**Electrode to specification:** Yes No N/A**Weld Procedures Followed:** Yes No N/A**Qualified Welders:** Yes No N/A**Verified Joint Fit-up:** Yes No N/A**Approved Drawings:** Yes No N/A**Approved WPS:** Yes No N/A**Delayed / Cancelled:** Yes No N/A**Bridge No:** 34-0006**Component:** TOWER & OBG Components**Summary of Items Observed:**

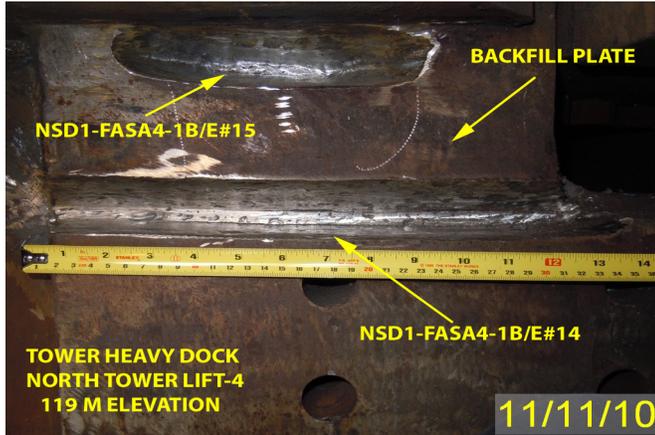
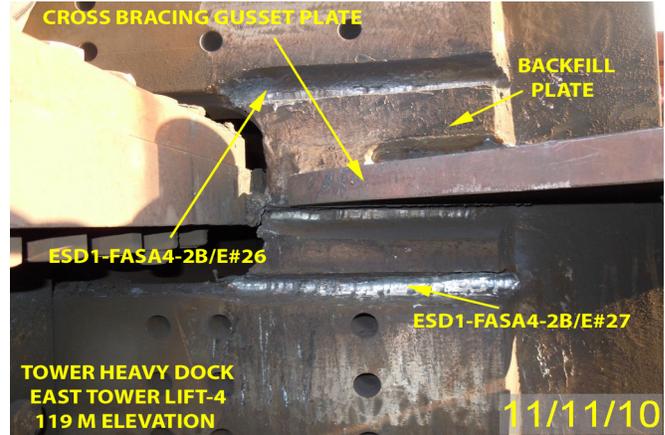
During the Caltrans Quality Assurance (QA) in-process observation on Lift-4 tower shafts, this QA Inspector discovered the following issues:

- After Ultrasonic Testing (UT) rejection of backfill plate welds by ZPMC quality control personnel, ZPMC fabrication personnel removed a total four (4) Non-SPCM welds without engineer notification.
- The Non-SPCM welds are Butt-Joint Complete Joint Penetration (CJP) welds joining backfill plate to doubler plate.
- These welds measured to be approximately 330 mm in length.
- Backfill plate thickness is 50 mm.

- 1) North Shaft - NSD1-FASA4-1B/E#14
- 2) North Shaft - NSD1-FASA4-1B/E#17
- 3) East Shaft - ESD1-FASA4-2B/E#26
- 4) East Shaft - ESD1-FASA4-2B/E#27

- The whole length of the Non-SPCM welds has been removed.
- The components are located at Tower Heavy Dock.

AWS D1.5 2002 Section 3.7.5: “The Engineer shall be notified before improperly fitted and welded members are cut apart”.
