**DEPARTMENT OF TRANSPORTATION**

Contract #: 04-0120F4Cty: SF/ALA Rte: 80 PM: 13.2/13.9File #: 69.28**WELDING INSPECTION REPORT****Resident Engineer:** Siegenthaler, Peter**Address:** 333 Burma Road**City:** Oakland, CA 94607**Report No:** WIR-018123**Date Inspected:** 12-Nov-2010**Project Name:** SAS Superstructure**OSM Arrival Time:** 700**Prime Contractor:** American Bridge/Fluor Enterprises, a JV**OSM Departure Time:** 1900**Contractor:** Zhenhua Port Machinery Company, Ltd (ZPMC), Changxing Island **Location:** Shanghai, China**CWI Name:** Li Yang**CWI Present:** Yes No**Inspected CWI report:** Yes No N/A**Rod Oven in Use:** Yes No N/A**Electrode to specification:** Yes No N/A**Weld Procedures Followed:** Yes No N/A**Qualified Welders:** Yes No N/A**Verified Joint Fit-up:** Yes No N/A**Approved Drawings:** Yes No N/A**Approved WPS:** Yes No N/A**Delayed / Cancelled:** Yes No N/A**Bridge No:** 34-0006**Component:** OBG Segment**Summary of Items Observed:**

**OBG # TRIAL ASSEMBLY YARD (11DE-11EE)**

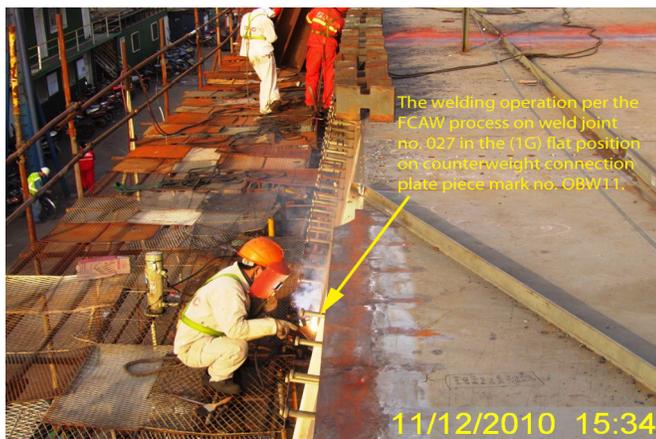
The QA Inspector observed the welding operation per the FCAW process on weld joint no. 027 in the (1G) flat position on counterweight connection plate piece mark no. OBW11. The location was the complete joint penetration groove weld joining the counterweight connection plate with the edge panel of 11BW and 11CW. The welder ID was 057333. The ZPMC CWI was identified as Li Yang. The welding variables recorded by QC appeared to comply with the WPS-B-T-2231-B-U2-F.

The QA Inspector observed the welding operation per the FCAW process on weld joint no. 027 in the (4G) overhead position on counterweight connection plate piece mark no. OBW11. The location was the complete joint penetration groove weld joining the counterweight connection plate with the edge panel of 11BW and 11CW. The welder ID was 041713. The ZPMC CWI was identified as Li Yang. The welding variables recorded by QC appeared to comply with the WPS-B-T-2231-B-U2-F.

For additional information please reference the pictures below:
