DEPARTMENT OF TRANSPORTATION

Quality Assurance and Source Inspection

Contract #: 04-0120F4Cty: SF/ALA Rte: 80 PM: 13.2/13.9File #: 1.28**WELDING INSPECTION REPORT****Resident Engineer:** Siegenthaler, Peter**Address:** 333 Burma Road**City:** Oakland, CA 94607**Report No:** WIR-018129**Date Inspected:** 10-Nov-2010**Project Name:** SAS Superstructure**OSM Arrival Time:** 1000**Prime Contractor:** American Bridge/Fluor Enterprises, a JV**OSM Departure Time:** 1830**Contractor:** American Bridge/Fluor Enterprises, a JV**Location:** Jobsite**CWI Name:** See below**CWI Present:** Yes No**Inspected CWI report:** Yes No N/A**Rod Oven in Use:** Yes No N/A**Electrode to specification:** Yes No N/A**Weld Procedures Followed:** Yes No N/A**Qualified Welders:** Yes No N/A**Verified Joint Fit-up:** Yes No N/A**Approved Drawings:** Yes No N/A**Approved WPS:** Yes No N/A**Delayed / Cancelled:** Yes No N/A**Bridge No:** 34-0006**Component:** SAS OBG**Summary of Items Observed:**

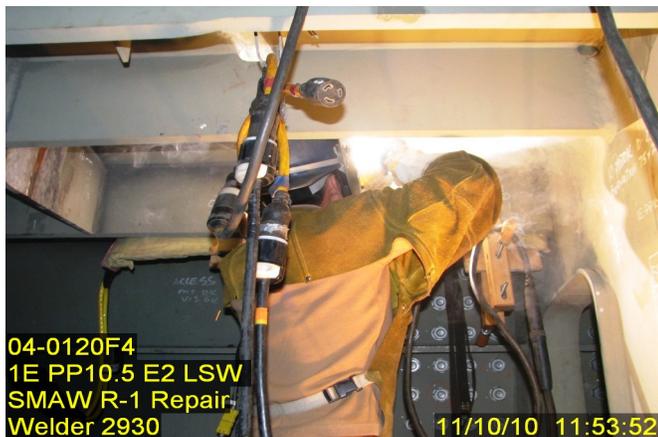
1E PP10.5 E2 LSW

The QAI periodically observed AB/F approved welder Hua Qiang Hwang (ID 2930) performing welding per the Shielded Metal Arc Welding (SMAW) process in the 3G (vertical) position of an R-1 repair in OBG Field Splice of Vent. Access Insert Long. Stiffeners at 1E PP10.5 E2 LSW. See photo below. QC Inspector John Pagliero was present to monitor the progress and verify that the welding parameters were within the limits established by the approved welding Procedure Specification (WPS) identified as ABF-WPS-D1.5-1012-3. The repair welding was completed at this location and appeared to be in general compliance with contract documents.
