**DEPARTMENT OF TRANSPORTATION**

Contract #: 04-0120F4Cty: SF/ALA Rte: 80 PM: 13.2/13.9File #: 1.28**WELDING INSPECTION REPORT****Resident Engineer:** Siegenthaler, Peter**Address:** 333 Burma Road**City:** Oakland, CA 94607**Report No:** WIR-018130**Date Inspected:** 11-Nov-2010**Project Name:** SAS Superstructure**OSM Arrival Time:** 1000**Prime Contractor:** American Bridge/Fluor Enterprises, a JV**OSM Departure Time:** 1730**Contractor:** American Bridge/Fluor Enterprises, a JV**Location:** Jobsite**CWI Name:** See below**CWI Present:** Yes No**Inspected CWI report:** Yes No N/A**Rod Oven in Use:** Yes No N/A**Electrode to specification:** Yes No N/A**Weld Procedures Followed:** Yes No N/A**Qualified Welders:** Yes No N/A**Verified Joint Fit-up:** Yes No N/A**Approved Drawings:** Yes No N/A**Approved WPS:** Yes No N/A**Delayed / Cancelled:** Yes No N/A**Bridge No:** 34-0006**Component:** SAS OBG**Summary of Items Observed:**

## WELDING INSPECTION REPORT

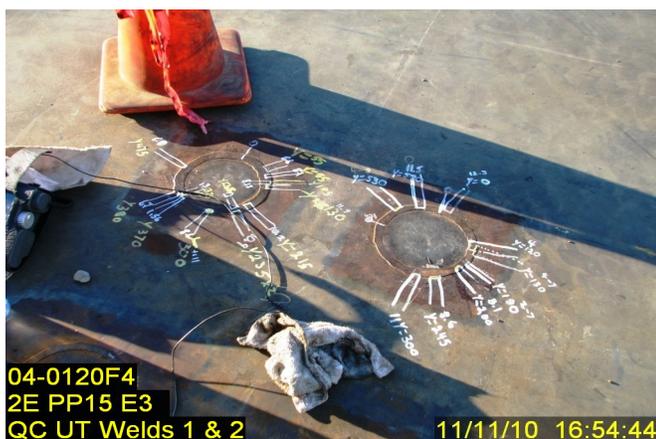
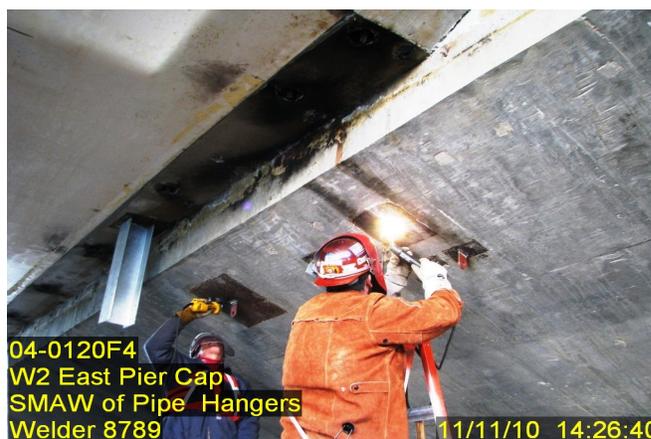
Location:	QC UT Results:
2E-PP15-E3 weld 1	10 Rejectable Indications
2E-PP15-E3 weld 2	10 Rejectable Indications

See photo below.
