Contract #: 04-0120F4Cty: SF/ALA Rte: 80 PM: 13.2/13.9File #: 1.28**WELDING INSPECTION REPORT****Resident Engineer:** Siegenthaler, Peter**Address:** 333 Burma Road**City:** Oakland, CA 94607**Report No:** WIR-018132**Date Inspected:** 10-Nov-2010**Project Name:** SAS Superstructure**OSM Arrival Time:** 630**Prime Contractor:** American Bridge/Fluor Enterprises, a JV**OSM Departure Time:** 1500**Contractor:** American Bridge/Fluor Enterprises, a JV**Location:** Job Site**CWI Name:** See Below**CWI Present:** Yes No**Inspected CWI report:** Yes No N/A**Rod Oven in Use:** Yes No N/A**Electrode to specification:** Yes No N/A**Weld Procedures Followed:** Yes No N/A**Qualified Welders:** Yes No N/A**Verified Joint Fit-up:** Yes No N/A**Approved Drawings:** Yes No N/A**Approved WPS:** Yes No N/A**Delayed / Cancelled:** Yes No N/A**Bridge No:** 34-0006**Component:** Orthotropic Box Girders**Summary of Items Observed:**

WELDING INSPECTION REPORT

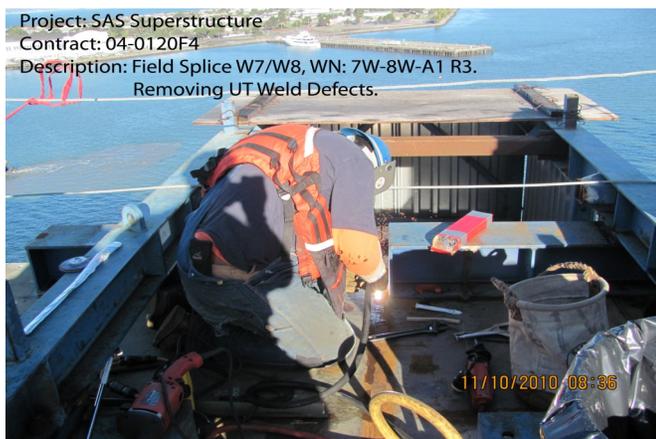
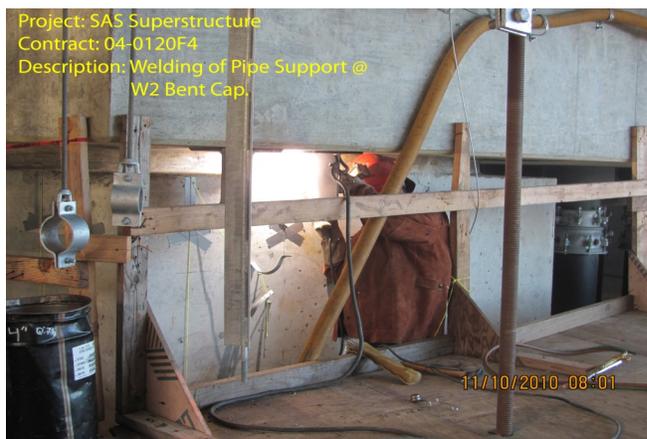
The digital photographs below illustrate the work observed during this scheduled shift.
