Contract #: 04-0120F4Cty: SF/ALA Rte: 80 PM: 13.2/13.9File #: 99.28**WELDING INSPECTION REPORT****Resident Engineer:** Siegenthaler, Peter**Address:** 333 Burma Road**City:** Oakland, CA 94607**Report No:** WIR-018206**Date Inspected:** 19-Nov-2010**Project Name:** SAS Superstructure**OSM Arrival Time:** 700**Prime Contractor:** American Bridge/Fluor Enterprises, a JV**OSM Departure Time:** 1900**Contractor:** Zhenhua Port Machinery Company, Ltd (ZPMC)**Location:** Shanghai, China**CWI Name:** Li Yang and Zhu Zhong Hai**CWI Present:** Yes No**Inspected CWI report:** Yes No N/A**Rod Oven in Use:** Yes No N/A**Electrode to specification:** Yes No N/A**Weld Procedures Followed:** Yes No N/A**Qualified Welders:** Yes No N/A**Verified Joint Fit-up:** Yes No N/A**Approved Drawings:** Yes No N/A**Approved WPS:** Yes No N/A**Delayed / Cancelled:** Yes No N/A**Bridge No:** 34-0006**Component:** OBG Trial Assembly**Summary of Items Observed:**

Orthotropic Box Girder (OBG) at Trial Assembly Areas

WELDING INSPECTION REPORT

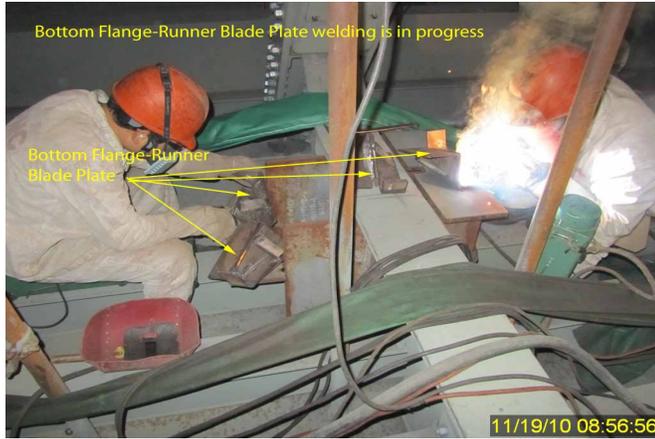
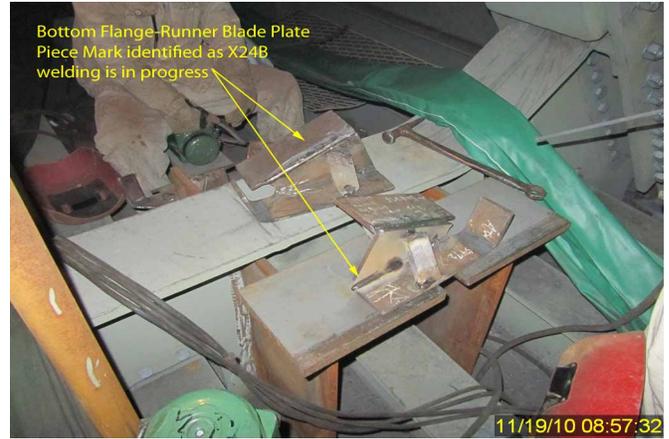
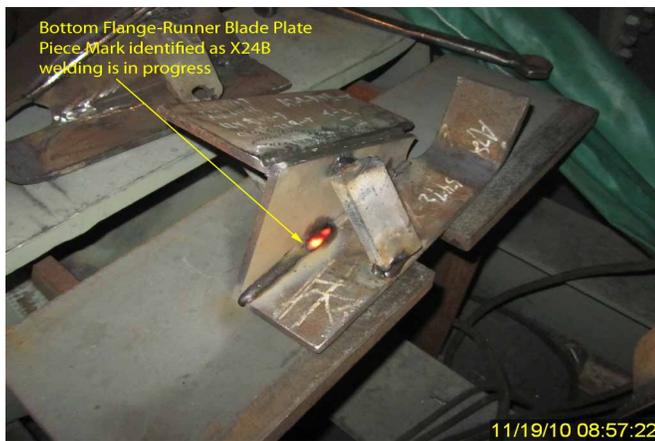
This QA Inspector observed the in-process welding by Shielded Metal Arc Welding (SMAW) process on a Complete Joint Penetration (CJP) groove weld. The Weld joint was designated as SSD016-PP98-93.

The welder identification was 044515 and was observed welding in the 2G (Horizontal) position using approved Welding Procedure Specification WPS-B-P-2212-Tc-U4b-FCM-1. The piece mark was identified as the Bottom Flange- Runner Blade Plate, piece mark identified as X24B.

Please reference the pictures attached for more comprehensive details.
