**DEPARTMENT OF TRANSPORTATION**

Contract #: 04-0120F4Cty: SF/ALA Rte: 80 PM: 13.2/13.9File #: 1.28**WELDING INSPECTION REPORT****Resident Engineer:** Siegenthaler, Peter**Address:** 333 Burma Road**City:** Oakland, CA 94607**Report No:** WIR-018217**Date Inspected:** 18-Nov-2010**Project Name:** SAS Superstructure**OSM Arrival Time:** 1000**Prime Contractor:** American Bridge/Fluor Enterprises, a JV**OSM Departure Time:** 1830**Contractor:** American Bridge/Fluor Enterprises, a JV**Location:** Job Site

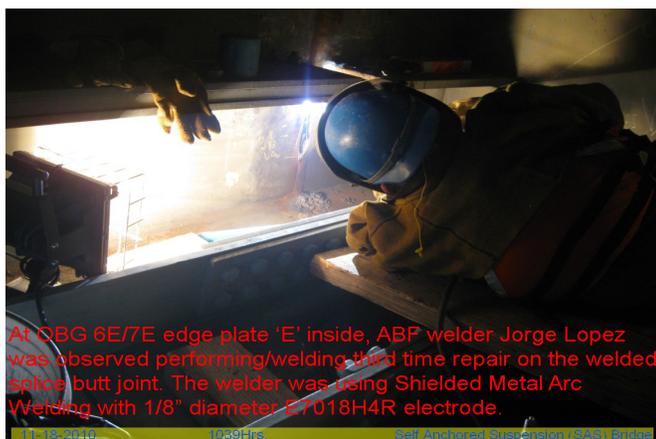
At OBG 6E/7E edge plate 'B' outside, QA randomly observed ABF/JV qualified welder Jorge Lopez ID #6149 perform CJP groove welding repair. The welder was observed welding the third time repair in the 3G (vertical) position utilizing Shielded Metal Arc Welding (SMAW) with 1/8" diameter E7018H4R electrode implementing welding procedure ABF-WPS-D15-1001-Repairs. The boat shape repair excavation was located at Y-dimension 1120mm and has a 120mm long x 33mm wide x 11mm deep excavation profile. The third time repair excavation was preheated to more than 140 degree Fahrenheit using propane gas torch prior welding. During the shift, ABF QC Bonifacio Daquinag was noted monitoring the welder. At the end of the shift, repair welding at above mentioned location was completed.

At OBG 6E/7E edge plate 'E' inside, ABF welder Jorge Lopez was observed performing/welding third time repair on the welded splice butt joint. The welder was using Shielded Metal Arc Welding with 1/8" diameter E7018H4R electrode.

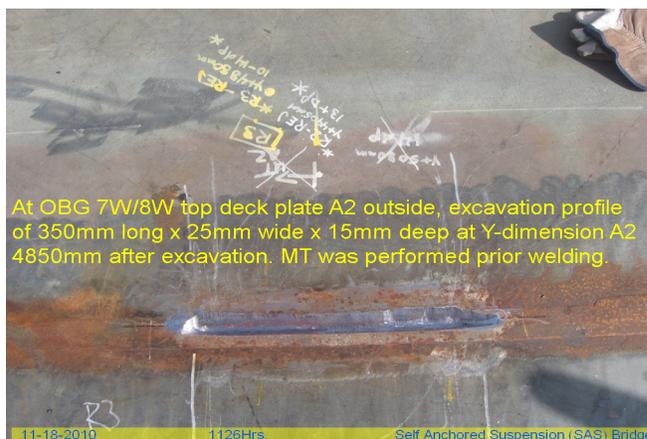
At 7W/8W top deck plate A2, QA randomly observed excavation of welding repair number four. The fourth time repair excavation was located at Y-dimension 4880mm and has 350mm long x 25mm wide x 15mm deep profile. After the excavation was completed, ABF QC Steven Mc Connell performed the Magnetic Particle Testing prior to start welding. During the test, there was no defect noted except the indication between the top deck plate and backing bar. The welder Kit Watlai proceeded with the repair using SMAW with 1/8" diameter E7018H4R electrode and during welding the welder made a burn through into the deck plate. The welder has stopped the repair welding due to the burn through. QA made verification on the condition of the plate underneath and after seeing the burn through there was like a linear indication that ran through the edge of the backing bar. ABF Superintendent Dan Ieraci also looked at the burn through underneath and after looking he decided to hold back the repair and to consult with QC Manager Mr. Jim Bowers prior to continue.

At OBG 7W/8W top deck plate A2 outside, excavation profile of 350mm long x 25mm wide x 15mm deep at Y-dimension A2 4850mm after excavation. MT was performed prior welding.
