DEPARTMENT OF TRANSPORTATION

Contract #: 04-0120F4Cty: SF/ALA Rte: 80 PM: 13.2/13.9File #: 69.28**WELDING INSPECTION REPORT****Resident Engineer:** Siegenthaler, Peter**Address:** 333 Burma Road**City:** Oakland, CA 94607**Report No:** WIR-018294**Date Inspected:** 21-Nov-2010**Project Name:** SAS Superstructure**OSM Arrival Time:** 700**Prime Contractor:** American Bridge/Fluor Enterprises, a JV**OSM Departure Time:** 1900**Contractor:** Zhenhua Port Machinery Company, Ltd (ZPMC), Changxing Island **Location:** Shanghai, China**CWI Name:** Li Yang**CWI Present:** Yes No**Inspected CWI report:** Yes No N/A**Rod Oven in Use:** Yes No N/A**Electrode to specification:** Yes No N/A**Weld Procedures Followed:** Yes No N/A**Qualified Welders:** Yes No N/A**Verified Joint Fit-up:** Yes No N/A**Approved Drawings:** Yes No N/A**Approved WPS:** Yes No N/A**Delayed / Cancelled:** Yes No N/A**Bridge No:** 34-0006**Component:** OBG Segment**Summary of Items Observed:**

OBG # TRIAL ASSEMBLY YARD (11BW)

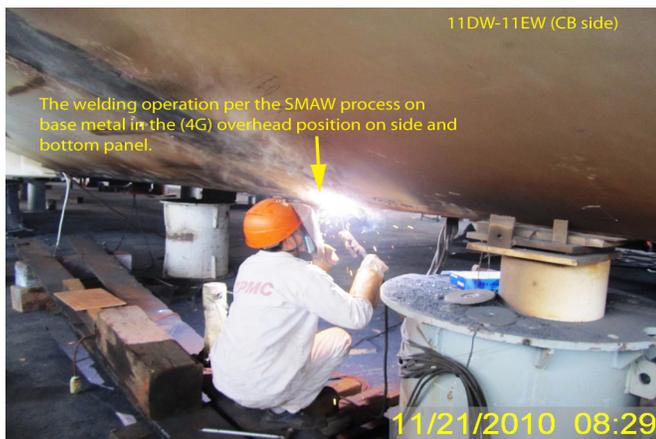
The QA Inspector observed the welding operation per the SMAW process on base metal in the (4G) overhead position on side and bottom panel. The location was the transverse splice weld joining segment 11DW and 11EW at crossbeam side. The welder ID was 040724. The welding was performed against critical welding repair report B-CWR1842. The welding variables recorded by QC appeared to comply with the WPS-345-SMAW-4G (4F)-FCM-Repair-1.

Unless otherwise noted, all work observed on this date appeared to generally comply with applicable contract documents.
