Contract #: 04-0120F4Cty: SF/ALA Rte: 80 PM: 13.2/13.9File #: 69.28**WELDING INSPECTION REPORT****Resident Engineer:** Siegenthaler, Peter**Address:** 333 Burma Road**City:** Oakland, CA 94607**Report No:** WIR-018297**Date Inspected:** 25-Nov-2010**Project Name:** SAS Superstructure**OSM Arrival Time:** 700**Prime Contractor:** American Bridge/Fluor Enterprises, a JV**OSM Departure Time:** 1900**Contractor:** Zhenhua Port Machinery Company, Ltd (ZPMC), Changxing Island **Location:** Shanghai, China**CWI Name:** Li Yang**CWI Present:** Yes No**Inspected CWI report:** Yes No N/A**Rod Oven in Use:** Yes No N/A**Electrode to specification:** Yes No N/A**Weld Procedures Followed:** Yes No N/A**Qualified Welders:** Yes No N/A**Verified Joint Fit-up:** Yes No N/A**Approved Drawings:** Yes No N/A**Approved WPS:** Yes No N/A**Delayed / Cancelled:** Yes No N/A**Bridge No:** 34-0006**Component:** OBG Segment**Summary of Items Observed:**

OBG # TRIAL ASSEMBLY YARD (11DW-11EW)

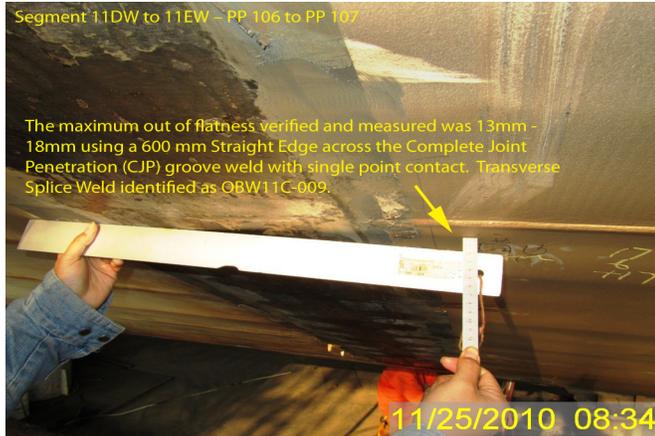
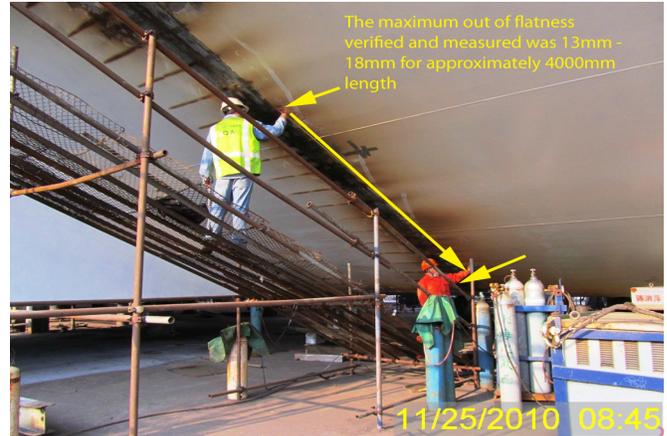
This QA inspector performed a random visual survey inspection for flatness of transverse splice segment weld at side panel crossbeam on Segment 11DW to Segment 11EW with the following observations. The maximum out of flatness verified and measured was 13mm - 18mm for approximately 4000mm length using a 600 mm Straight Edge across the Complete Joint Penetration (CJP) groove weld with single point contact. The surface flatness survey data was taken on the exterior side (flat side of the weld) of the side panel. The allowable tolerance is 10mm.

Segment 11DW to 11EW – PP 106 to PP 107

Transverse Splice Weld identified as OBW11C-009.

The measurements were forwarded to team leader for review and disposition. The segment and panel point designations were as follows:
