DEPARTMENT OF TRANSPORTATION

Contract #: 04-0120F4Cty: SF/ALA Rte: 80 PM: 13.2/13.9File #: 69.28**WELDING INSPECTION REPORT****Resident Engineer:** Siegenthaler, Peter**Address:** 333 Burma Road**City:** Oakland, CA 94607**Report No:** WIR-018300**Date Inspected:** 26-Nov-2010**Project Name:** SAS Superstructure**OSM Arrival Time:** 700**Prime Contractor:** American Bridge/Fluor Enterprises, a JV**OSM Departure Time:** 1900**Contractor:** Zhenhua Port Machinery Company, Ltd (ZPMC), Changxing Island **Location:** Shanghai, China**CWI Name:** Zhu Zhong Hai**CWI Present:** Yes No**Inspected CWI report:** Yes No N/A**Rod Oven in Use:** Yes No N/A**Electrode to specification:** Yes No N/A**Weld Procedures Followed:** Yes No N/A**Qualified Welders:** Yes No N/A**Verified Joint Fit-up:** Yes No N/A**Approved Drawings:** Yes No N/A**Approved WPS:** Yes No N/A**Delayed / Cancelled:** Yes No N/A**Bridge No:** 34-0006**Component:** Orthotropic Box Girder (OBG)**Summary of Items Observed:**

WELDING INSPECTION REPORT

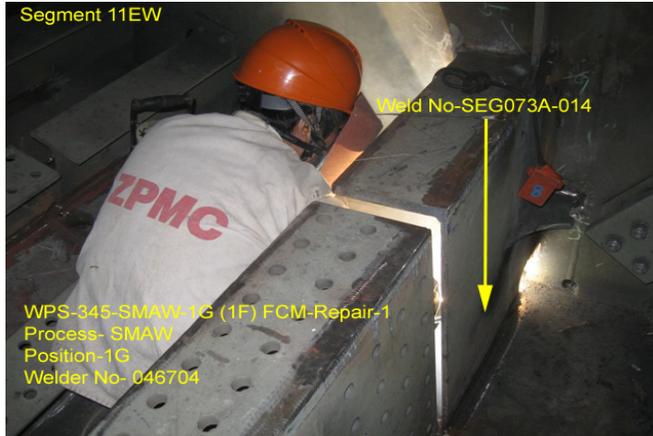
This QA Inspector observed ZPMC qualified welding personnel identified as 046704 perform Shielded Metal Arc Welding (SMAW), weld joint identified as SEG073A-014; located On Orthotropic Box Girder (OBG) Bottom Plate to Side Plate CJP Weld; The Welding Repair Report (WRR) was B-WR17734. ZPMC Quality Control (QC) is identified as Mr. Zhou Peng. The welding variables recorded by QC appeared to comply with applicable WPS-345-FCAW -1G (1F) FCM-Repair-1. See attached photo for further details.

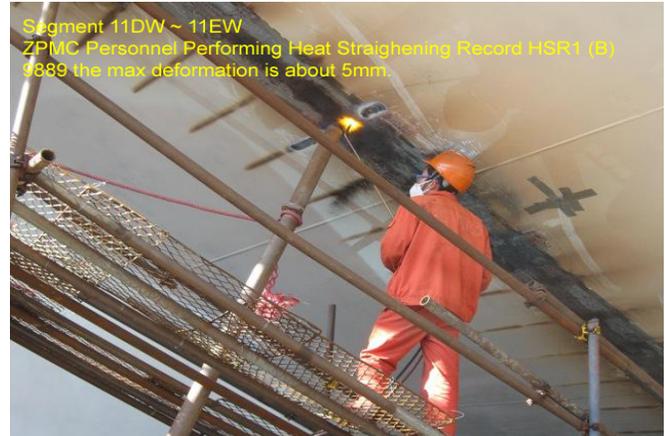
ZPMC personnel heat straightening Orthotropic Box Girder (OBG) member identified as Segment 11DW~ 11EW Panel Point 106 to Panel Point 107 Side Plate to Side Plate Transverse Splice CJP Weld. Distortion appeared to be caused by Welding. ZPMC Quality Control (QC) inspector identified as Mr. Zhu Zhong Hai was present to monitor the heat straightening process. The heat straightening appeared to comply with Heat Straightening Report HSR1 (B) 9889. See attached photo for further details.
