DEPARTMENT OF TRANSPORTATION

Quality Assurance and Source Inspection

Contract #: 04-0120F4Cty: SF/ALA Rte: 80 PM: 13.2/13.9File #: 69.28**WELDING INSPECTION REPORT****Resident Engineer:** Siegenthaler, Peter**Address:** 333 Burma Road**City:** Oakland, CA 94607**Report No:** WIR-018338**Date Inspected:** 10-Nov-2010**Project Name:** SAS Superstructure**OSM Arrival Time:** 700**Prime Contractor:** American Bridge/Fluor Enterprises, a JV**OSM Departure Time:** 1900**Contractor:** Zhenhua Port Machinery Company, Ltd (ZPMC), Changxing Island **Location:** Shanghai, China**CWI Name:** Zhu Feng**CWI Present:** Yes No**Inspected CWI report:** Yes No N/A**Rod Oven in Use:** Yes No N/A**Electrode to specification:** Yes No N/A**Weld Procedures Followed:** Yes No N/A**Qualified Welders:** Yes No N/A**Verified Joint Fit-up:** Yes No N/A**Approved Drawings:** Yes No N/A**Approved WPS:** Yes No N/A**Delayed / Cancelled:** Yes No N/A**Bridge No:** 34-0006**Component:** TOWER & OBG Components**Summary of Items Observed:**

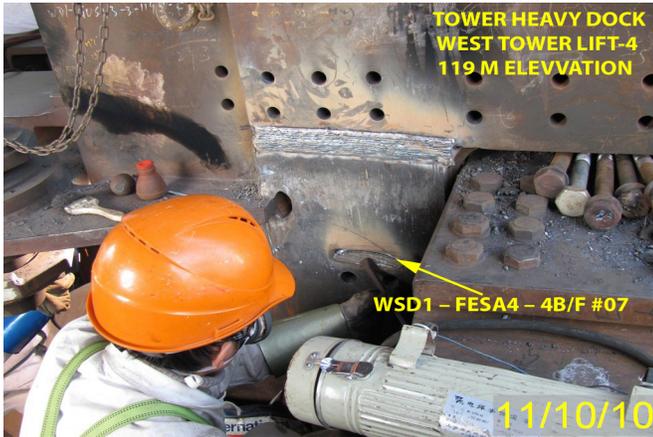
Repair welding of weld joint # 07 located on West tower Lift-4 Skin 'E', 119 M Backfill plate WSD1 – FESA4 – 4B/F as per the weld repair report # T-WR3741. Welder is identified as 040690. ZPMC Quality Control (QC) Inspector is identified Sun Zi Wang. The welding variables recorded by QC appeared to comply with the WPS – 485 – SMAW – 2G (2F) – Repair – 1. (See attached photo)

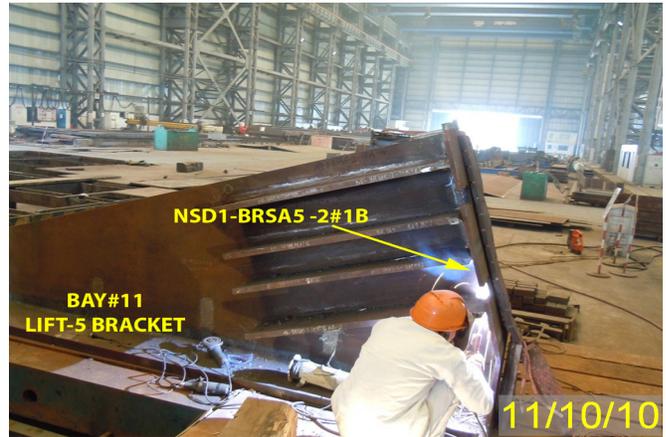
Weld joint # 1B located on Lift-5 bracket ND1 – BRSA5 – 2. Welder is identified as 040724. ZPMC Quality Control (QC) Inspector is identified as Xu Jie. The welding variables recorded by QC appeared to comply with the WPS – B – T – 3213 – TC – U5b. (See attached photo)
