Contract #: 04-0120F4Cty: SF/ALA Rte: 80 PM: 13.2/13.9File #: 69.28**WELDING INSPECTION REPORT****Resident Engineer:** Siegenthaler, Peter**Address:** 333 Burma Road**City:** Oakland, CA 94607**Report No:** WIR-018341**Date Inspected:** 16-Nov-2010**Project Name:** SAS Superstructure**OSM Arrival Time:** 700**Prime Contractor:** American Bridge/Fluor Enterprises, a JV**OSM Departure Time:** 1900**Contractor:** Zhenhua Port Machinery Company, Ltd (ZPMC), Changxing Island **Location:** Shanghai, China

Bridge No: 34-0006**Component:** TOWER & OBG Components**Summary of Items Observed:**

WELDING INSPECTION REPORT

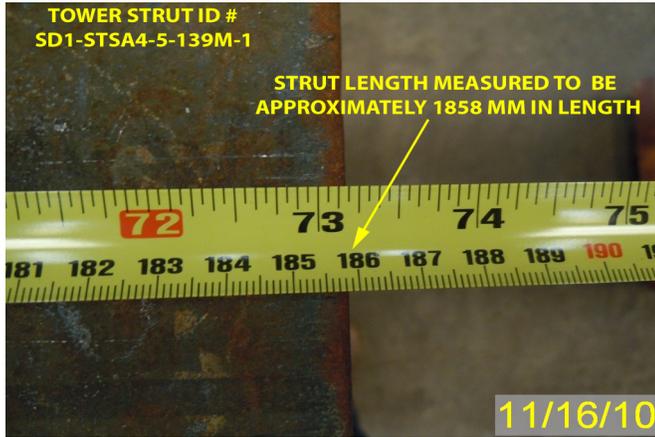
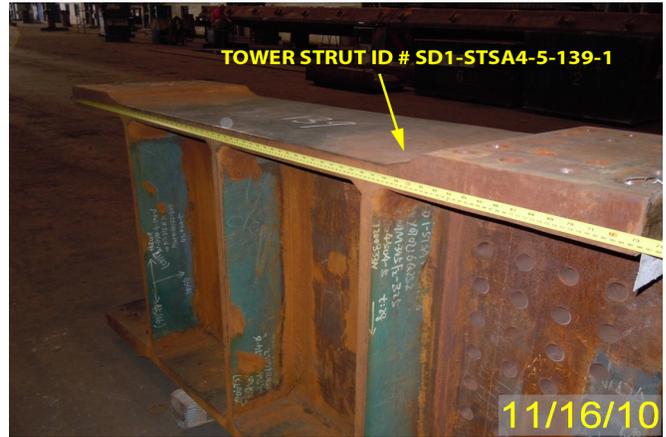
During the survey on the tower struts mentioned above, the following strut length found to be out of tolerance as per the ABF-RFI-1945R01:

1. SD1-STSA4-5-139M-1 - Measured length is 1858 mm, but required is 1860 mm with the tolerance +20 / -0. (Strut type-3)

For further information please see the below attached pictures.
