**DEPARTMENT OF TRANSPORTATION**

Contract #: 04-0120F4Cty: SF/ALA Rte: 80 PM: 13.2/13.9File #: 69.28**WELDING INSPECTION REPORT****Resident Engineer:** Siegenthaler, Peter**Address:** 333 Burma Road**City:** Oakland, CA 94607**Report No:** WIR-018350**Date Inspected:** 28-Nov-2010**Project Name:** SAS Superstructure**OSM Arrival Time:** 700**Prime Contractor:** American Bridge/Fluor Enterprises, a JV**OSM Departure Time:** 1900**Contractor:** Zhenhua Port Machinery Company, Ltd (ZPMC), Changxing Island **Location:** Shanghai, China**CWI Name:** Mr. Xu Le Feng**CWI Present:** Yes No**Inspected CWI report:** Yes No N/A**Rod Oven in Use:** Yes No N/A**Electrode to specification:** Yes No N/A**Weld Procedures Followed:** Yes No N/A**Qualified Welders:** Yes No N/A**Verified Joint Fit-up:** Yes No N/A**Approved Drawings:** Yes No N/A**Approved WPS:** Yes No N/A**Delayed / Cancelled:** Yes No N/A**Bridge No:** 34-0006**Component:** Tower / OBG**Summary of Items Observed:**

## WELDING INSPECTION REPORT

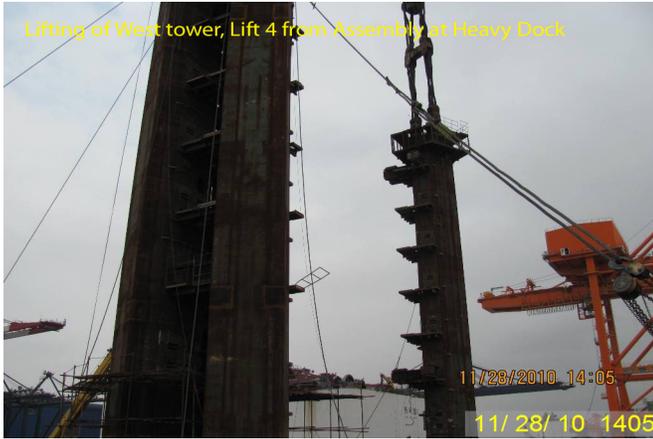
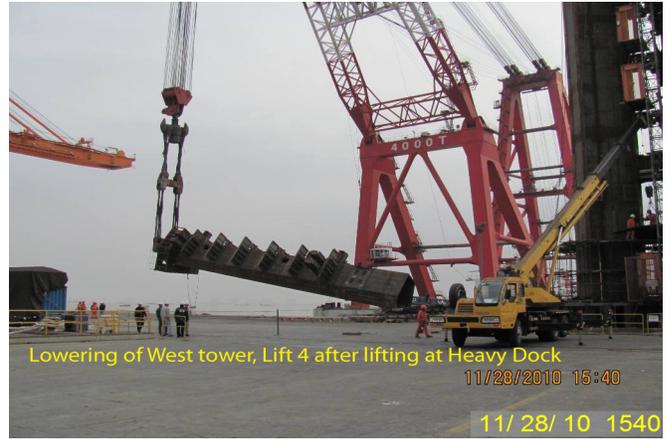
For further information see below pictures:-
