DEPARTMENT OF TRANSPORTATION

Contract #: 04-0120F4Cty: SF/ALA Rte: 80 PM: 13.2/13.9File #: 69.28**WELDING INSPECTION REPORT****Resident Engineer:** Siegenthaler, Peter**Address:** 333 Burma Road**City:** Oakland, CA 94607**Report No:** WIR-018351**Date Inspected:** 18-Nov-2010**Project Name:** SAS Superstructure**OSM Arrival Time:** 700**Prime Contractor:** American Bridge/Fluor Enterprises, a JV**OSM Departure Time:** 1900**Contractor:** Zhenhua Port Machinery Company, Ltd (ZPMC), Changxing Island **Location:** Shanghai, China**CWI Name:** Xu Le Feng**CWI Present:** Yes No**Inspected CWI report:** Yes No N/A**Rod Oven in Use:** Yes No N/A**Electrode to specification:** Yes No N/A**Weld Procedures Followed:** Yes No N/A**Qualified Welders:** Yes No N/A**Verified Joint Fit-up:** Yes No N/A**Approved Drawings:** Yes No N/A**Approved WPS:** Yes No N/A**Delayed / Cancelled:** Yes No N/A**Bridge No:** 34-0006**Component:** TOWER & OBG Components**Summary of Items Observed:**

EAST TOWER LIFT-4 AT 119M ELEVATION, BACKFILL PLATE

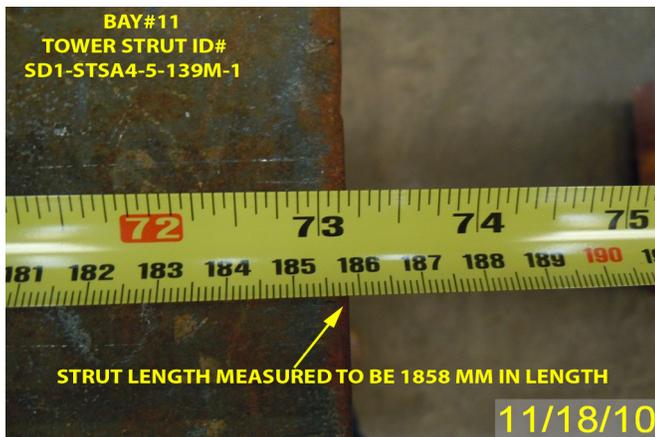
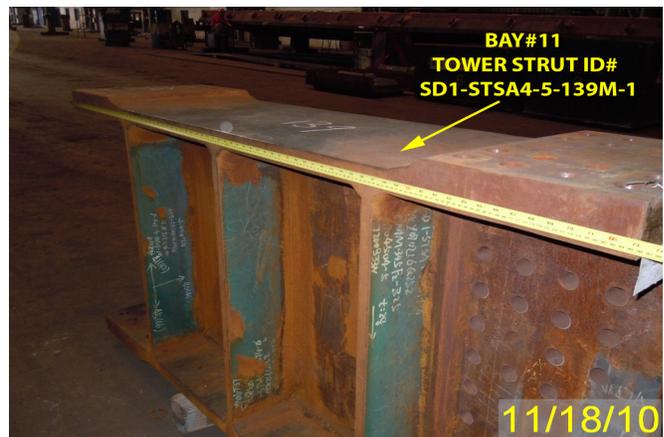
During the Caltrans Quality Assurance (QA) dimensional verification on Lift-4 Tower Struts, this QA Inspector discovered the following issue:

- One of the type-3A tower struts measured to be approximately 1858 mm in length.
- As per the ABF-RFI-1945R01, type-3 struts length cannot be shorter than 1860 mm.
- Tower strut identified as SD1-STSA4-5-139M-1.
- The component located at fabrication Bay#11.

ABF-RF1-001945R01 – “STRUTS CANNOT BE SHORTER THAN 1860 MM FOR TYPE-3”
