DEPARTMENT OF TRANSPORTATION

Contract #: 04-0120F4Cty: SF/ALA Rte: 80 PM: 13.2/13.9File #: 69.28**WELDING INSPECTION REPORT****Resident Engineer:** Siegenthaler, Peter**Address:** 333 Burma Road**City:** Oakland, CA 94607**Report No:** WIR-018368**Date Inspected:** 20-Nov-2010**Project Name:** SAS Superstructure**OSM Arrival Time:** 700**Prime Contractor:** American Bridge/Fluor Enterprises, a JV**OSM Departure Time:** 1900**Contractor:** Zhenhua Port Machinery Company, Ltd (ZPMC), Changxing Island **Location:** Shanghai, China**CWI Name:** Mr. Xu Le Fung.**CWI Present:** Yes No**Inspected CWI report:** Yes No N/A**Rod Oven in Use:** Yes No N/A**Electrode to specification:** Yes No N/A**Weld Procedures Followed:** Yes No N/A**Qualified Welders:** Yes No N/A**Verified Joint Fit-up:** Yes No N/A**Approved Drawings:** Yes No N/A**Approved WPS:** Yes No N/A**Delayed / Cancelled:** Yes No N/A**Bridge No:** 34-0006**Component:** Tower and Orthotropic Box Girder (OBG)**Summary of Items Observed:**

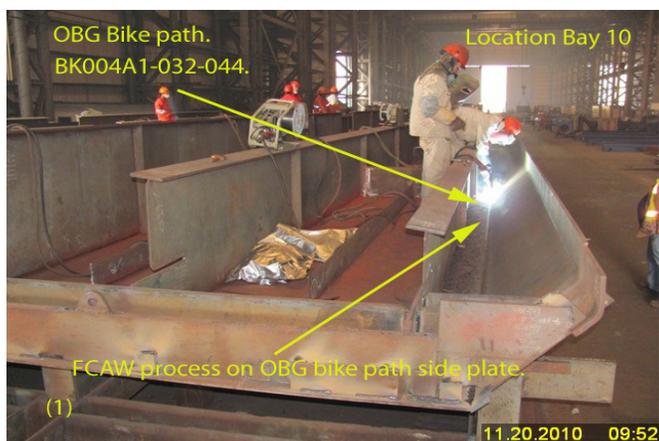
This QA Inspector observed ZPMC qualified welding personnel identified as 053869, 040533 Perform Flux Core Arc Welding (FCAW) on OBG Bike path. Joint identified as BK004A1-032-044. ZPMC QC Identified as Lijun. The welding parameters as measured using QC's calibrated instrument appeared to be in general compliance with WPS-B-T-2231-B-U2-F. For more information see below attached picture number 1.

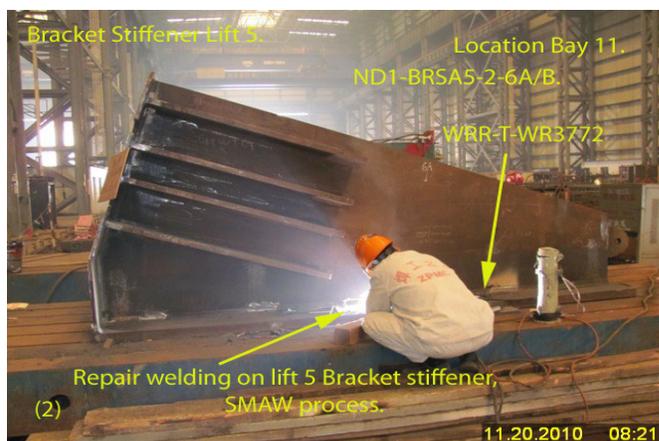
This QA Inspector observed ZPMC qualified welding personnel identified as 044541, Perform Shielded Metal Arc Welding (SMAW) on Tower Bracket Stiffener lift 5. Joint identified as ND1-BRSA5-2-6A/B. ZPMC QC Identified as Libin with temporary welding repair report WRR-T-WR3772. The welding parameters as measured using QC's calibrated instrument appeared to be in general compliance with WPS-485-SMAW-2G (2F) Repair -1. For more information see below attached picture number 2.
