Contract #: 04-0120F4Cty: SF/ALA Rte: 80 PM: 13.2/13.9File #: 69.28**WELDING INSPECTION REPORT****Resident Engineer:** Siegenthaler, Peter**Address:** 333 Burma Road**City:** Oakland, CA 94607**Report No:** WIR-018375**Date Inspected:** 24-Nov-2010**Project Name:** SAS Superstructure**OSM Arrival Time:** 700**Prime Contractor:** American Bridge/Fluor Enterprises, a JV**OSM Departure Time:** 1900**Contractor:** Zhenhua Port Machinery Company, Ltd (ZPMC), Changxing Island **Location:** Shanghai, China**CWI Name:** Xu Le Feng**CWI Present:** Yes No**Inspected CWI report:** Yes No N/A**Rod Oven in Use:** Yes No N/A**Electrode to specification:** Yes No N/A**Weld Procedures Followed:** Yes No N/A**Qualified Welders:** Yes No N/A**Verified Joint Fit-up:** Yes No N/A**Approved Drawings:** Yes No N/A**Approved WPS:** Yes No N/A**Delayed / Cancelled:** Yes No N/A**Bridge No:** 34-0006**Component:** TOWER & OBG Components**Summary of Items Observed:**

ORTHOTROPIC BOX GIRDER (OBG) AT BAY#10

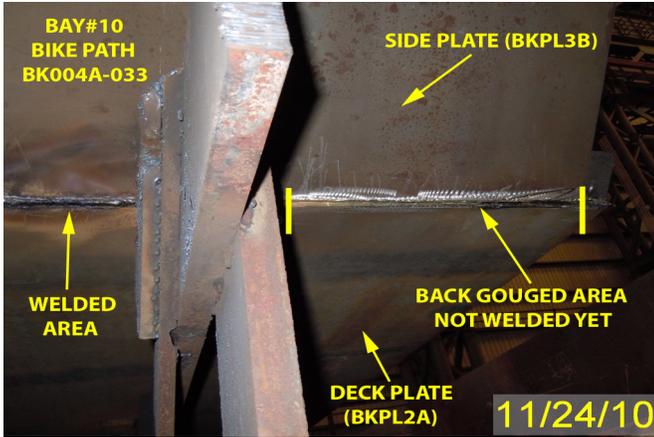
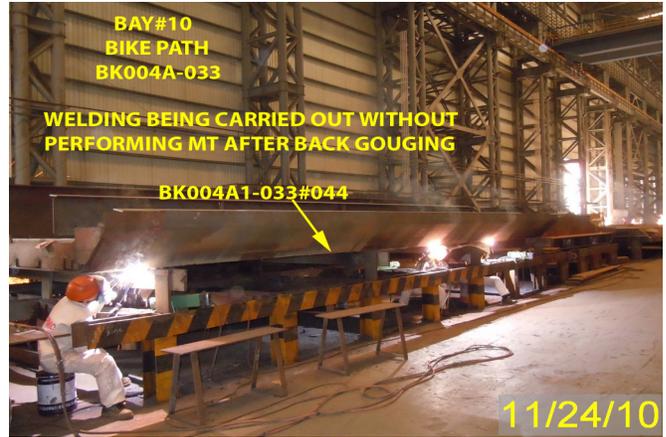
During Caltrans QA in process observations of the fabrication of Bike Path BK004A-033, this QA discovered the following issue(s):

ZPMC welding personnel did not appear to be following the NEW WELD PROCEDURE (Rager / McQuaid)

The weld is identified as BK004A1-033-044.

The welding process used was Shielded Metal Arc Welding (SMAW).

The weld is a Complete Joint Penetration (CJP) joining Deck Plate (BKPL2A) to Side Plate (BKPL3B).

A. All back gouged groove welds are to have their gouged areas ground to bright metal and inspected 100% by VT and MT examination before welding may begin from the second side.
