DEPARTMENT OF TRANSPORTATION

Contract #: 04-0120F4Cty: SF/ALA Rte: 80 PM: 13.2/13.9File #: 69.28**WELDING INSPECTION REPORT****Resident Engineer:** Siegenthaler, Peter**Address:** 333 Burma Road**City:** Oakland, CA 94607**Report No:** WIR-018384**Date Inspected:** 28-Nov-2010**Project Name:** SAS Superstructure**OSM Arrival Time:** 700**Prime Contractor:** American Bridge/Fluor Enterprises, a JV**OSM Departure Time:** 1900**Contractor:** Zhenhua Port Machinery Company, Ltd (ZPMC), Changxing Island **Location:** Shanghai, China**CWI Name:** Mr. Chen xi**CWI Present:** Yes No**Inspected CWI report:** Yes No N/A**Rod Oven in Use:** Yes No N/A**Electrode to specification:** Yes No N/A**Weld Procedures Followed:** Yes No N/A**Qualified Welders:** Yes No N/A**Verified Joint Fit-up:** Yes No N/A**Approved Drawings:** Yes No N/A**Approved WPS:** Yes No N/A**Delayed / Cancelled:** Yes No N/A**Bridge No:** 34-0006**Component:** Orthotropic Box Girder (OBG)**Summary of Items Observed:**

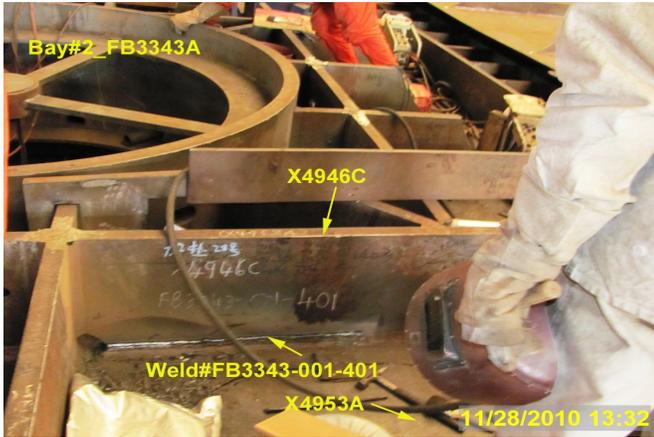
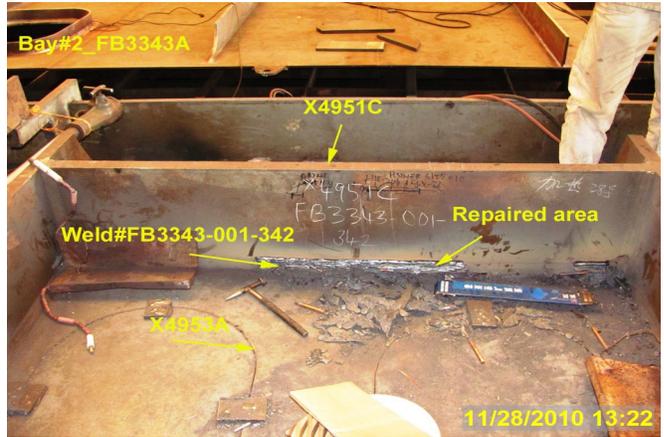
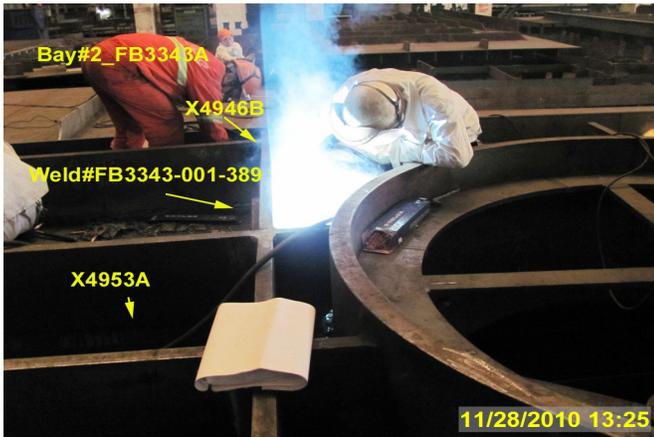
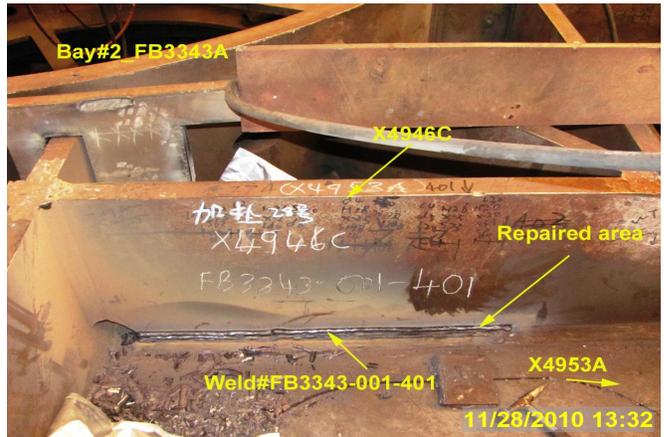
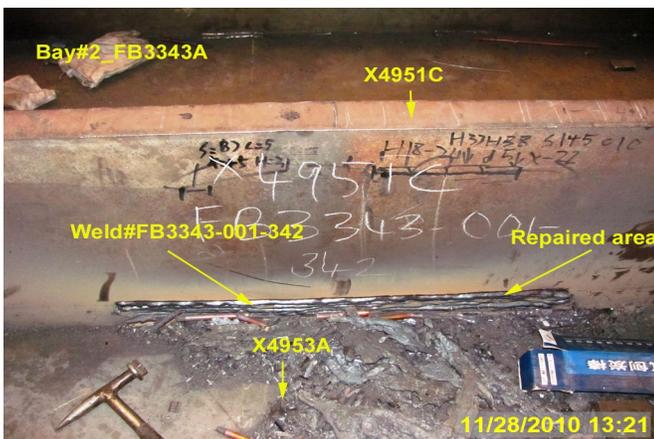
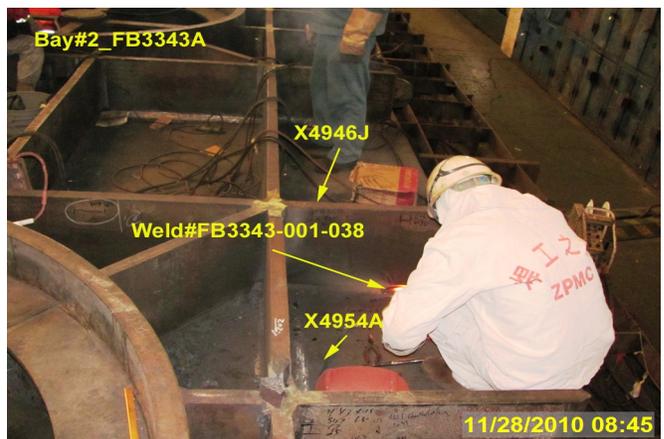
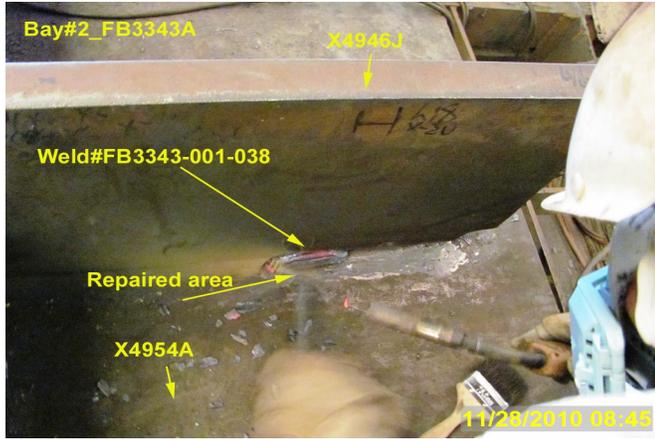
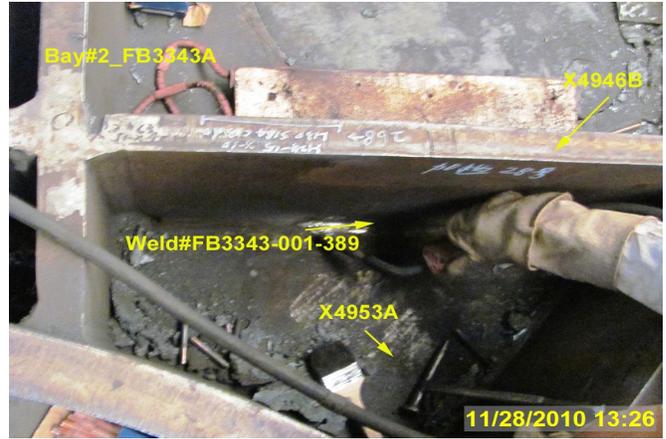
FCAW Repair welding of weld joint FB3343-001-389. Welder is identified as 066236. ZPMC Quality Control (QC) is identified as Mr. Xu jie. The welding variables appeared to comply with the Applicable WPS: WPS-345-FCAW-2G (2F)-Repair. The repair welding was being performed as per the Welding Repair Report (WRR) No: B-WR17863. This weld was rejected by ZPMC UT Technicians and recorded on UT report No: B787-UT-17554. Refer the attached photos for reference.

FCAW Repair welding of weld joint FB3343-001-342. Welder is identified as 067520. ZPMC Quality Control (QC) is identified as Mr. Xu jie. The welding variables appeared to comply with the Applicable WPS: WPS-345-FCAW-2G (2F)-Repair. The repair welding was being performed as per the Welding Repair Report (WRR) No: B-WR17885. This weld was rejected by ZPMC UT Technicians and recorded on UT report No: B787-UT-17554. Refer the attached photos for reference.

FCAW Repair welding of weld joint FB3343-001-401. Welder is identified as 070006. ZPMC Quality Control (QC) is identified as Mr. Xu jie. The welding variables appeared to comply with the Applicable WPS: WPS-345-FCAW-2G (2F)-Repair. The repair welding was being performed as per the Welding Repair Report (WRR) No: B-WR17860. This weld was rejected by ZPMC UT Technicians and recorded on UT report No: B787-UT-17554. Refer the attached photos for reference.

FCAW Repair welding of weld joint FB3343-001-038. Welder is identified as 066695. ZPMC Quality Control (QC) is identified as Mr. Xu jie. The welding variables appeared to comply with the Applicable WPS: WPS-345-FCAW-2G (2F)-Repair. The repair welding was being performed as per the Welding Repair Report (WRR) No: B-WR17858. This weld was rejected by ZPMC UT Technicians and recorded on UT report No: B787-UT-17554. Refer the attached photos for reference.
