**DEPARTMENT OF TRANSPORTATION**

Contract #: 04-0120F4Cty: SF/ALA Rte: 80 PM: 13.2/13.9File #: 69.28**WELDING INSPECTION REPORT****Resident Engineer:** Siegenthaler, Peter**Address:** 333 Burma Road**City:** Oakland, CA 94607**Report No:** WIR-018386**Date Inspected:** 25-Nov-2010**Project Name:** SAS Superstructure**OSM Arrival Time:** 700**Prime Contractor:** American Bridge/Fluor Enterprises, a JV**OSM Departure Time:** 1900**Contractor:** Zhenhua Port Machinery Company, Ltd (ZPMC), Changxing Island **Location:** Shanghai, China**CWI Name:** Mr. Chen xi**CWI Present:** Yes No**Inspected CWI report:** Yes No N/A**Rod Oven in Use:** Yes No N/A**Electrode to specification:** Yes No N/A**Weld Procedures Followed:** Yes No N/A**Qualified Welders:** Yes No N/A**Verified Joint Fit-up:** Yes No N/A**Approved Drawings:** Yes No N/A**Approved WPS:** Yes No N/A**Delayed / Cancelled:** Yes No N/A**Bridge No:** 34-0006**Component:** Orthotropic Box Girder (OBG)**Summary of Items Observed:**

## WELDING INSPECTION REPORT

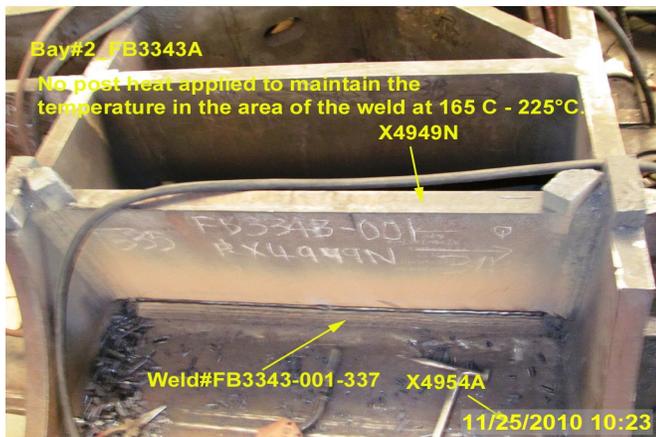
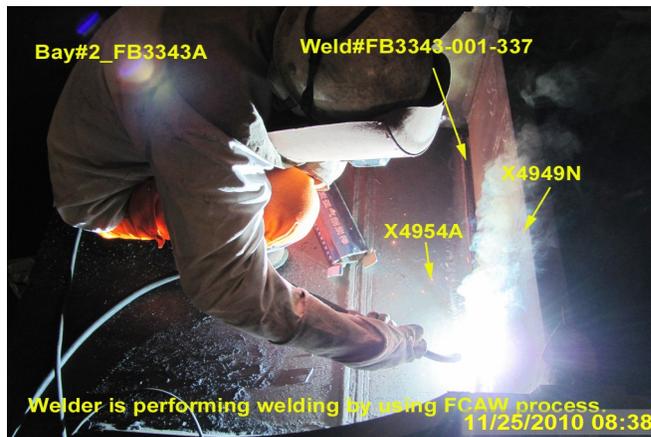
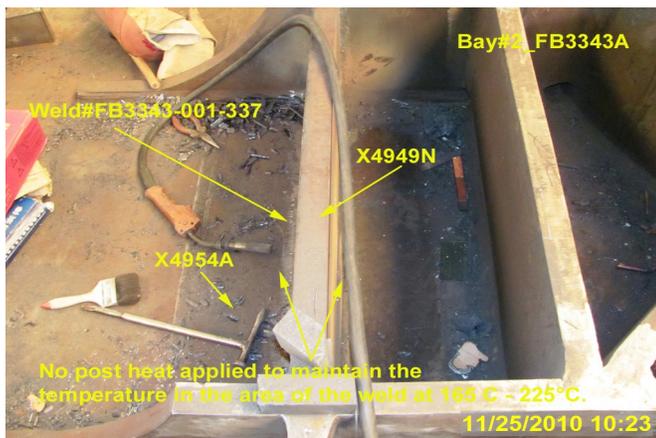
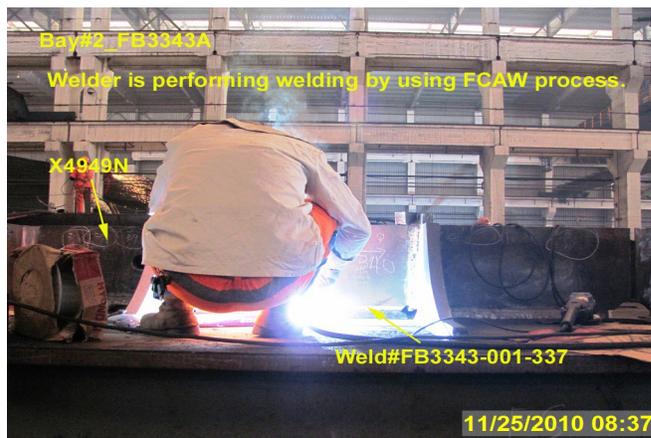
During Caltrans QA in process observations of the fabrication of FB3343A , this QA observed ZPMC welding personnel did not appear to be following the NEW WELD PROCEDURE (Rager / McQuaid).ZPMC Welding personnel did not applied the post heat after completion of welding to maintain the temperature in the area of the weld at 165 C - 225°C. The weld is identified as FB3343-001-337.The welding process used was Flux Cored Arc Welding. The area was being preheated using electric strip heaters. The weld is a Complete Joint Penetration with steel backing joining FB web plate (X4954A) to Stiffener plate (X4949N).The weld is not Seismic Performance Critical Material. The FB web base material thickness is 50 mm and stiffener plate is 45 mm.

This QA Inspector generated an incident report on this date for the above issue, for further information see the incident Report and attached photos.
