**DEPARTMENT OF TRANSPORTATION**

Contract #: 04-0120F4Cty: SF/ALA Rte: 80 PM: 13.2/13.9File #: 69.28**WELDING INSPECTION REPORT****Resident Engineer:** Siegenthaler, Peter**Address:** 333 Burma Road**City:** Oakland, CA 94607**Report No:** WIR-018390**Date Inspected:** 21-Nov-2010**Project Name:** SAS Superstructure**OSM Arrival Time:** 700**Prime Contractor:** American Bridge/Fluor Enterprises, a JV**OSM Departure Time:** 1900**Contractor:** Zhenhua Port Machinery Company, Ltd (ZPMC), Changxing Island **Location:** Shanghai, China**CWI Name:** Mr. Chen xi**CWI Present:** Yes No**Inspected CWI report:** Yes No N/A**Rod Oven in Use:** Yes No N/A**Electrode to specification:** Yes No N/A**Weld Procedures Followed:** Yes No N/A**Qualified Welders:** Yes No N/A**Verified Joint Fit-up:** Yes No N/A**Approved Drawings:** Yes No N/A**Approved WPS:** Yes No N/A**Delayed / Cancelled:** Yes No N/A**Bridge No:** 34-0006**Component:** Orthotropic Box Girder (OBG)**Summary of Items Observed:**

## WELDING INSPECTION REPORT

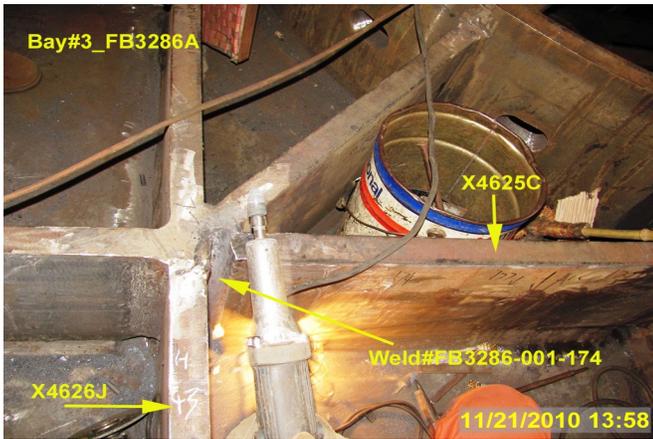
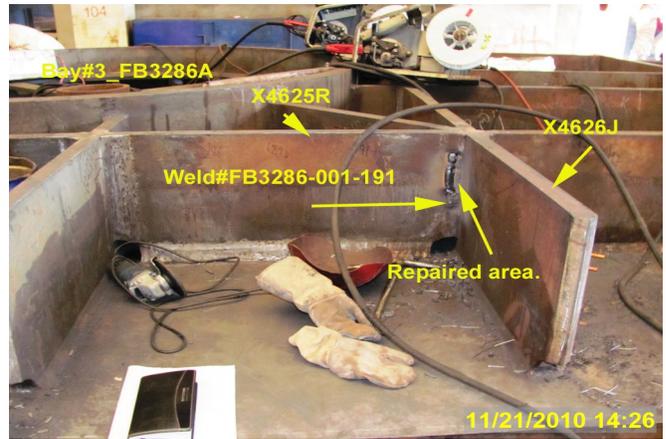
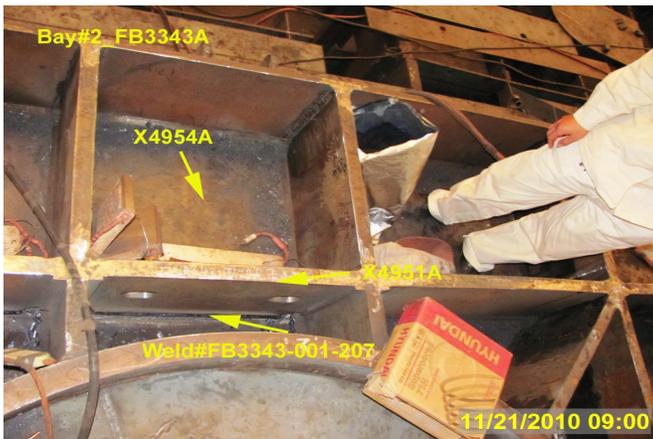
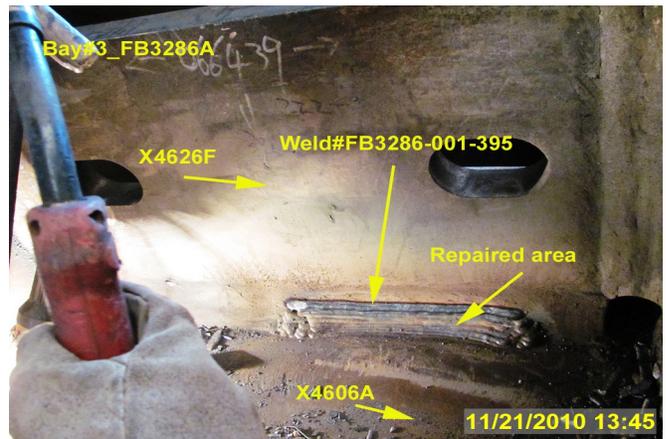
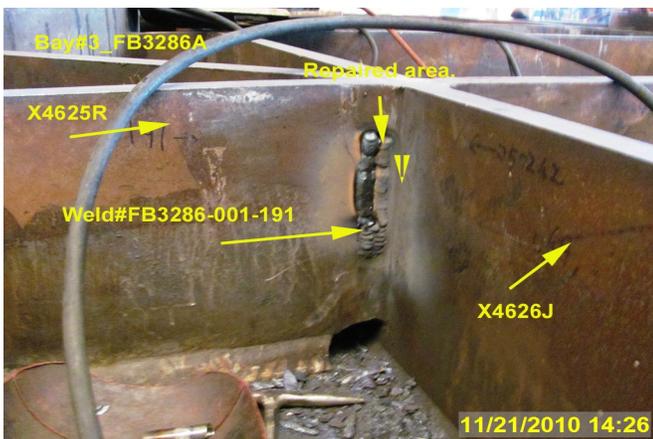
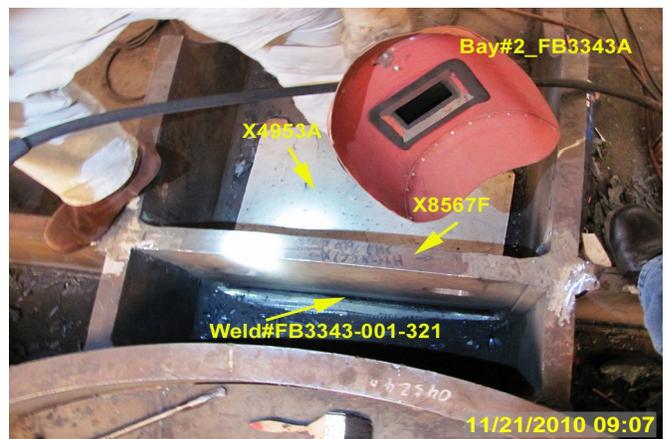
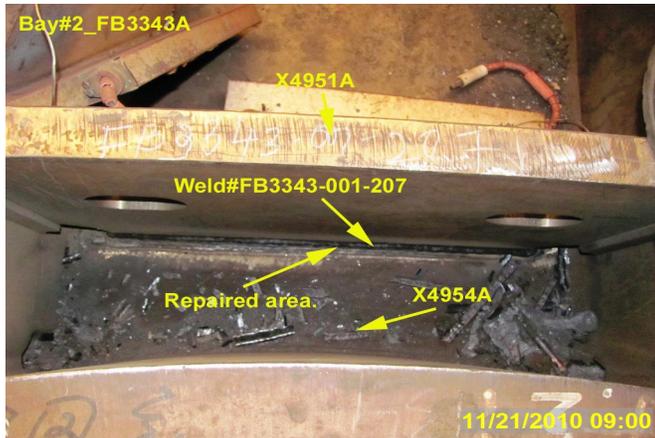
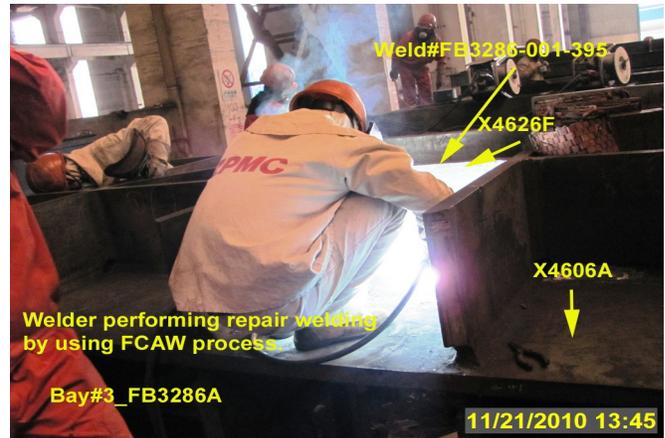
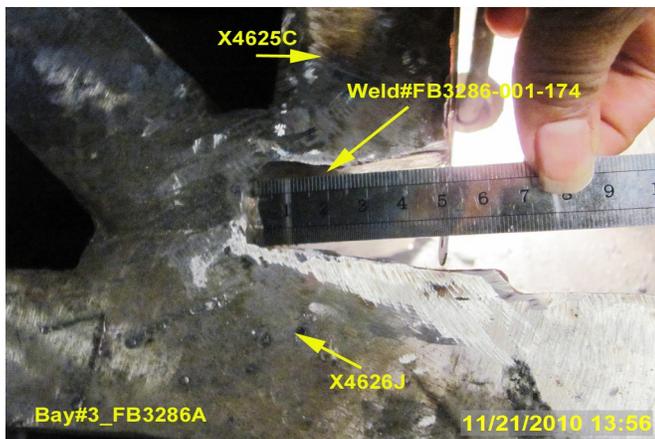
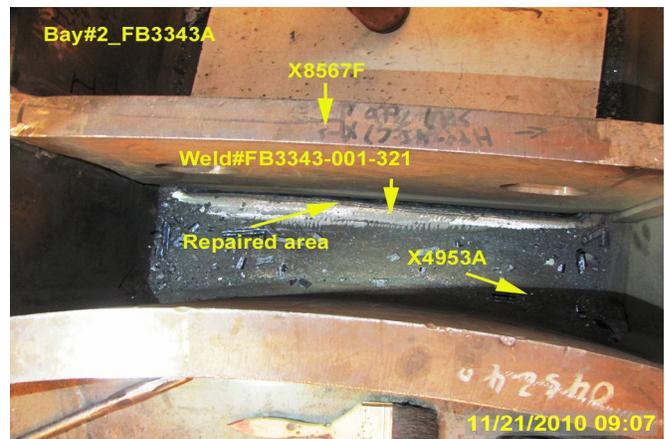
Flux Cored Arc Welding (FCAW) Repair welding of weld joint FB3286-001-395. Welder is identified as 050242. ZPMC Quality Control (QC) is identified as Mr. Zhan hai feng. The welding variables appeared to comply with the Applicable WPS: WPS-345-FCAW-2G (2F)-Repair. The repair welding was being performed as per the Welding Repair Report (WRR) No: B-WR17494. This weld was rejected by ZPMC UT Technicians and recorded on UT report No: B787-UT-17584. Refer the attached photos for reference.

FCAW Repair welding of weld joint FB3286-001-191. Welder is identified as 052696. ZPMC Quality Control (QC) is identified as Mr. Zhan hai feng. The welding variables appeared to comply with the Applicable WPS: WPS-345-FCAW-2G (2F)-Repair. The repair welding was being performed as per the Welding Repair Report (WRR) No: B-WR17456. This weld was rejected by ZPMC UT Technicians and recorded on UT report No: B787-UT-17584. Refer the attached photos for reference.

During QA random in-process observations of the fabrication of OBG lift 14, East Floor beam FB3286A, this QA observed ZPMC workers have removed an entire CJP weld joint to perform a weld repair. ZPMC failed to notify the

Engineer of the intent to remove the entire weld. Due to the manner in which ZPMC excavated the weld, they appear

to have altered the specified weld joint detail as shown on WD481AG. The weld is a Complete Joint Penetration (CJP) with backing joining stiffener X4625C to stiffener X4626J. After being informed of this incident report, ZPMC has commenced repair welding of this joint using Flux cored Arc Welding (FCAW) in the vertical (3G) position. The repair joint preparation did not appear to comply with the contract documents concerning gouged grooves. The weld joint is identified as FB3286-001-174. ZPMC has prepared welding repair report (WRR) no. B-WR-17455 concerning this repair. The stiffener material thickness is 45 mm. The depth of excavation is approximately 50mm.

FCAW Repair welding of weld joint FB3343-001-321. Welder is identified as 067876. ZPMC Quality Control (QC) is identified as Mr. Xu jie. The welding variables appeared to comply with the Applicable WPS: WPS-345-FCAW-2G (2F)-Repair. The repair welding was being performed as per the Welding Repair Report (WRR) No: B-WR17372. This weld was rejected by ZPMC UT Technicians and recorded on UT report No: B787-UT-17521. Refer the attached photos for reference.

FCAW Repair welding of weld joint FB3343-001-207. Welder is identified as 068917. ZPMC Quality Control (QC) is identified as Mr. Xu jie. The welding variables appeared to comply with the Applicable WPS: WPS-345-FCAW-2G (2F)-Repair. The repair welding was being performed as per the Welding Repair Report (WRR) No: B-WR17394. This weld was rejected by ZPMC UT Technicians and recorded on UT report No: B787-UT-17521. Refer the attached photos for reference.

This QA Inspector generated an incident report on this date for the above issue, for further information see the incident report.
