**DEPARTMENT OF TRANSPORTATION**

Contract #: 04-0120F4Cty: SF/ALA Rte: 80 PM: 13.2/13.9File #: 1.28**WELDING INSPECTION REPORT****Resident Engineer:** Siegenthaler, Peter**Address:** 333 Burma Road**City:** Oakland, CA 94607**Report No:** WIR-018407**Date Inspected:** 23-Nov-2010**Project Name:** SAS Superstructure**OSM Arrival Time:** 630**Prime Contractor:** American Bridge/Fluor Enterprises, a JV**OSM Departure Time:** 1500**Contractor:** American Bridge/Fluor Enterprises, a JV**Location:** Job Site**CWI Name:** See Below**CWI Present:** Yes No**Inspected CWI report:** Yes No N/A**Rod Oven in Use:** Yes No N/A**Electrode to specification:** Yes No N/A**Weld Procedures Followed:** Yes No N/A**Qualified Welders:** Yes No N/A**Verified Joint Fit-up:** Yes No N/A**Approved Drawings:** Yes No N/A**Approved WPS:** Yes No N/A**Delayed / Cancelled:** Yes No N/A**Bridge No:** 34-0006**Component:** Orthotropic Box Girders**Summary of Items Observed:**

# WELDING INSPECTION REPORT

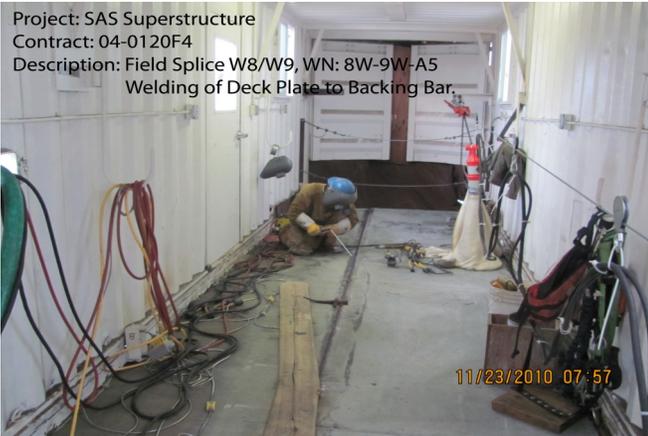
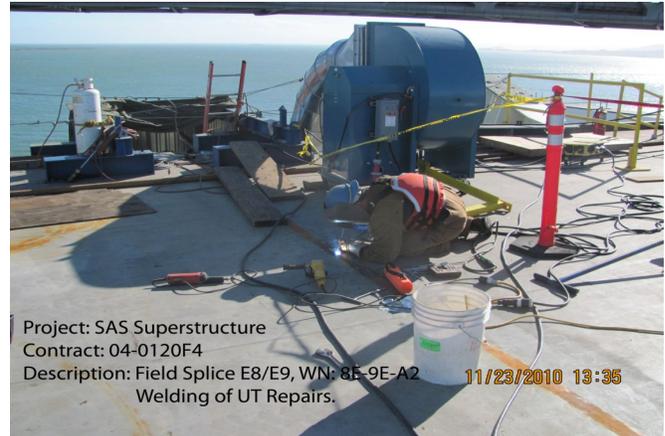
The digital photographs on page 4 of this report illustrate the work observed during this scheduled shift.
