Contract #: 04-0120F4Cty: SF/ALA Rte: 80 PM: 13.2/13.9File #: 1.28**WELDING INSPECTION REPORT****Resident Engineer:** Siegenthaler, Peter**Address:** 333 Burma Road**City:** Oakland, CA 94607**Report No:** WIR-018429**Date Inspected:** 30-Nov-2010**Project Name:** SAS Superstructure**OSM Arrival Time:** 630**Prime Contractor:** American Bridge/Fluor Enterprises, a JV**OSM Departure Time:** 1500**Contractor:** American Bridge/Fluor Enterprises, a JV**Location:** Job Site**CWI Name:** Listed below.**CWI Present:** Yes No**Inspected CWI report:** Yes No N/A**Rod Oven in Use:** Yes No N/A**Electrode to specification:** Yes No N/A**Weld Procedures Followed:** Yes No N/A**Qualified Welders:** Yes No N/A**Verified Joint Fit-up:** Yes No N/A**Approved Drawings:** Yes No N/A**Approved WPS:** Yes No N/A**Delayed / Cancelled:** Yes No N/A**Bridge No:** 34-0006**Component:** S.A.S. Components**Summary of Items Observed:**

1) OBG Deck Hole Welding

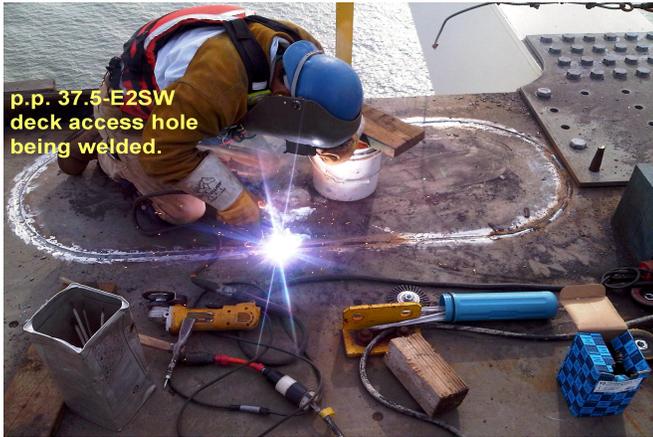
The QAI made observations of welding of the OBG deck hole patches on the East and West lines of the S.A.S. OBG structure. The QAI noted that the patches are being placed in the deck access / ventilation holes and lifting lug holes. The QAI observed Salvador Sandoval, ID 2202, and Mike Jininez, ID 4671, using shielded metal arc welding (SMAW) to make repairs to lifting lug patch welds. The QAI noted that repairs are being made at Panel Point (PP) 27-E4 and PP27-E3. The QAI also noted that the repairs include in-process work and repairs of deficient welds. The QAI noted that the repair welding is being monitored by the Quality Control (QC) Inspector Pat Swain. The QAI was informed that welding procedure specification (WPS) ABF-WPS-D15-1001-Repair is being used for this welding. The QAI randomly measured the welding parameters and noted that they appeared to be conforming to the WPS requirements. The QAI noted that as the repairs were completed, the welds were being ground smooth and flush with the deck surface. This work was in progress at the end of the shift. See the attached photo.
