**DEPARTMENT OF TRANSPORTATION**

Contract #: 04-0120F4Cty: SF/ALA Rte: 80 PM: 13.2/13.9File #: 1.28**WELDING INSPECTION REPORT****Resident Engineer:** Siegenthaler, Peter**Address:** 333 Burma Road**City:** Oakland, CA 94607**Report No:** WIR-018431**Date Inspected:** 02-Dec-2010**Project Name:** SAS Superstructure**OSM Arrival Time:** 1000**Prime Contractor:** American Bridge/Fluor Enterprises, a JV**OSM Departure Time:** 1830**Contractor:** American Bridge/Fluor Enterprises, a JV**Location:** Job Site

# WELDING INSPECTION REPORT

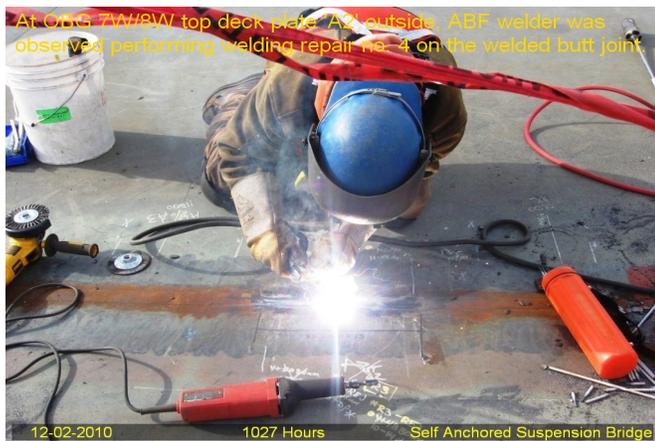
At OBG 7W/8W top deck plate 'A2' outside, QA randomly observed ABF/JV qualified welder Wai Kitlai perform CJP groove welding repair number 4. The welder was observed welding in the 1G (flat) position utilizing Shielded Metal Arc Welding (SMAW) with 1/8" diameter E7018H4R electrode implementing welding procedure ABF-WPS-D15-1001-Repairs. The repair excavation located at A2 Y-dimension 4880mm and having excavation profile of 360mm long x 25mm wide x 14mm deep was preheated to more than 140 degree Fahrenheit using propane gas torch prior welding. Prior welding, ABF QC Steven Mc Connell was observed performing Magnetic Particle Testing (MT) on the boat shape repair excavation. During the shift, ABF QC Mc Connell was noted monitoring the welder and his welding parameters. Repair welding at location mentioned above was completed at the end of the shift.

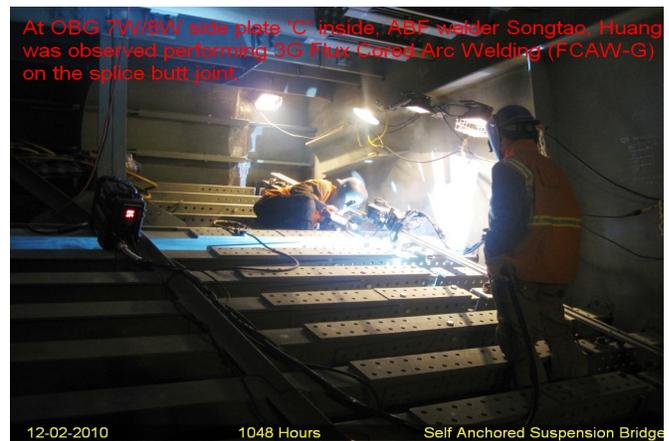
At OBG 7W/8W side plate 'C' (1000mm to 3200mm) inside, QA randomly observed ABF/JV qualified welder Sungtao, Huang ID # 3794 continuing to perform CJP groove welding cover pass on the splice butt joint. The welder was observed welding in the 3G (vertical) position utilizing a dual shield Flux Cored Arc Welding (FCAW-G) with E71T-1M, 1/16" diameter wire electrode and implementing Caltrans approved Welding Procedure Specification (WPS) ABF-WPS-D15-3042B-1. The joint being welded has a single V-groove butt joint with backing bar. During the FCAW welding, the splice joint was preheated and maintained to greater than 150 degrees Fahrenheit using Miller Proheat 35 Induction Heating System heater blankets located at the opposite side

of the plate prior/during welding. ABF Quality Control (QC) William Sherwood was noted monitoring the welding parameters of the welder. During the shift, cover pass FCAW welding was completed and the welder has moved to 0mm to 1000mm and welded the area using the SMAW due to limited access of the track mounted Bug-o FCAW nozzle holder. At the end of the shift, fill pass welding of the splice joint at location mentioned above was still continuing and should remain tomorrow.

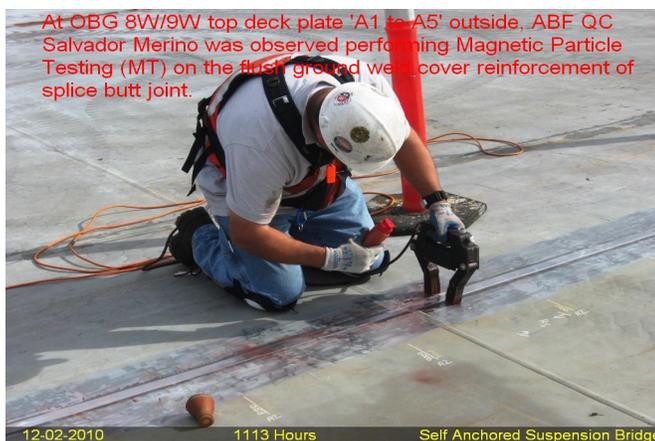
At OBG 8W/9W top deck plate 'A' outside, this QA performed 10% MT verification on the welded splice butt joint. QA was using Parker Contour Probe Model DA 400 electromagnetic yoke. QA found no defects during the verification and this should confirm the test performed by QC. Please see TL-6028 report for more information.
