DEPARTMENT OF TRANSPORTATION

Contract #: 04-0120F4Cty: SF/ALA Rte: 80 PM: 13.2/13.9File #: 1.28**WELDING INSPECTION REPORT****Resident Engineer:** Siegenthaler, Peter**Address:** 333 Burma Road**City:** Oakland, CA 94607**Report No:** WIR-018432**Date Inspected:** 03-Dec-2010**Project Name:** SAS Superstructure**OSM Arrival Time:** 900**Prime Contractor:** American Bridge/Fluor Enterprises, a JV**OSM Departure Time:** 1730**Contractor:** American Bridge/Fluor Enterprises, a JV**Location:** Job Site**CWI Name:** Mike Johnson and Pat Swain**CWI Present:** Yes No**Inspected CWI report:** Yes No N/A**Rod Oven in Use:** Yes No N/A**Electrode to specification:** Yes No N/A**Weld Procedures Followed:** Yes No N/A**Qualified Welders:** Yes No N/A**Verified Joint Fit-up:** Yes No N/A**Approved Drawings:** Yes No N/A**Approved WPS:** Yes No N/A**Delayed / Cancelled:** Yes No N/A**Bridge No:** 34-0006**Component:** Orthotropic Box Girder**Summary of Items Observed:**

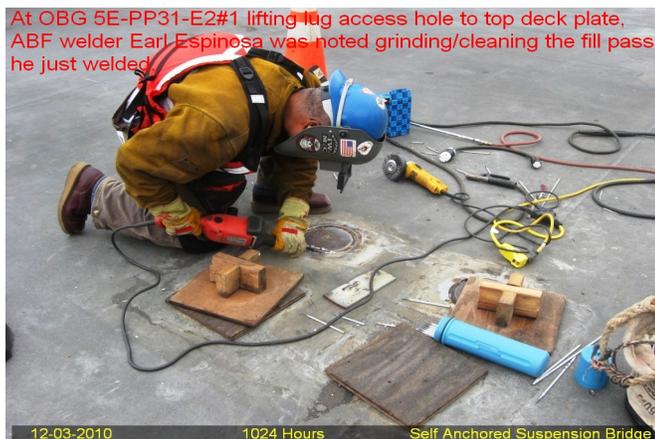
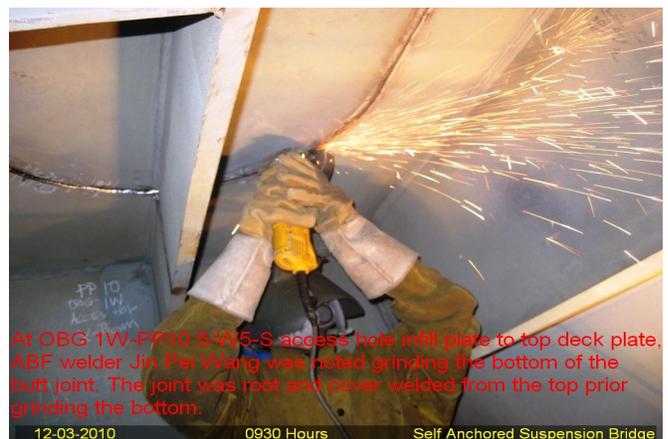
1. At OBG 5E-PP31-E2#1 top deck plate outside – ABF welder Earl Espinosa was observed 1G SMAW welding fill to cover pass on the infill plate to top deck plate butt joint. The welder was noted using 1/8” diameter E7018H4R electrode implementing Caltrans approved Welding Procedure Specification (WPS) ABF-WPS-D15-1070. During welding, ABF QC Pat Swain was noted monitoring the welder’s welding parameters. During the shift, cover pass welding on this location was completed and the welder has moved to a new access hole #3. The welder also welded fill pass using the same procedure mentioned above. At the end of the shift, fill pass welding was still continuing and should remain Monday.

3. At OBG 1W-PP8.5-E4#1 top deck plate inside - ABF welder Mike Jimenez was observed 4G SMAW back welding fill pass on the infill plate to top deck plate butt joint. The welder was noted using 1/8" diameter E7018H4R electrode implementing Caltrans approved Welding Procedure Specification (WPS) ABF-WPS-D15-1110A. During welding, ABF QC Mike Johnson was noted monitoring the welder's welding parameters. During the shift, fill pass welding on this location was still continuing which should remain Monday.

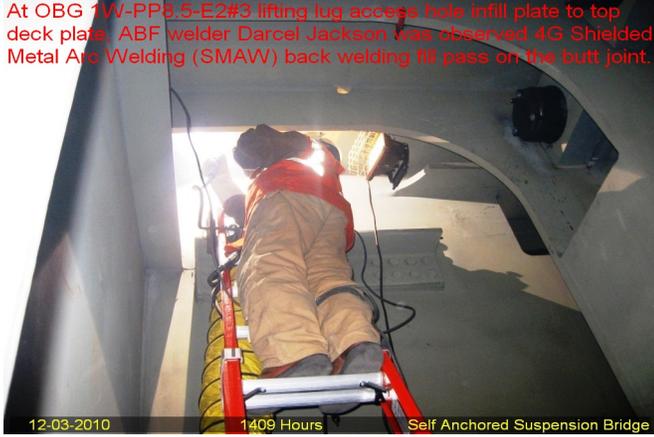
At OBG 1W-PP8.5-E2#3 lifting lug access hole infill plate to top deck plate ABF welder Darcel Jackson was observed 4G Shielded Metal Arc Welding (SMAW) back welding fill pass on the butt joint.

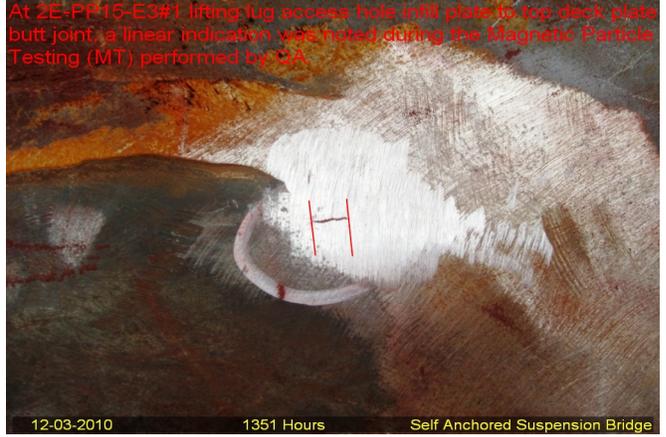
1. 1E-PP11-E4 #1, 2, 3 & 4 outside – no defects noted.
2. 2E-PP15-E3 #2, 3 & 4 outside – no defects noted. Hole no. 1 was noted with linear indication but was gone after grinding.
3. 2E-PP15-E4 #1, 2, 3 & 4 outside – no defects noted.
4. 2E-PP17-E3 #1, 2, 3 & 4 outside – no defects noted.
5. 2E-PP17-E4 #1, 2, 3 & 4 outside – no defects noted.
6. 3E-PP20-E4 #1, 2, 3 & 4 outside – no defects noted.

At 2E-PF15-E3#1 lifting lug access hole infill plate to top deck plate butt joint a linear indication was noted during the Magnetic Particle Testing (MT) performed by QA.
