**DEPARTMENT OF TRANSPORTATION**

Contract #: 04-0120F4Cty: SF/ALA Rte: 80 PM: 13.2/13.9File #: 1.28**WELDING INSPECTION REPORT****Resident Engineer:** Siegenthaler, Peter**Address:** 333 Burma Road**City:** Oakland, CA 94607**Report No:** WIR-018436**Date Inspected:** 01-Dec-2010**Project Name:** SAS Superstructure**OSM Arrival Time:** 630**Prime Contractor:** American Bridge/Fluor Enterprises, a JV**OSM Departure Time:** 1500**Contractor:** American Bridge/Fluor Enterprises, a JV**Location:** Job Site**CWI Name:** See Below**CWI Present:** Yes No**Inspected CWI report:** Yes No N/A**Rod Oven in Use:** Yes No N/A**Electrode to specification:** Yes No N/A**Weld Procedures Followed:** Yes No N/A**Qualified Welders:** Yes No N/A**Verified Joint Fit-up:** Yes No N/A**Approved Drawings:** Yes No N/A**Approved WPS:** Yes No N/A**Delayed / Cancelled:** Yes No N/A**Bridge No:** 34-0006**Component:** Orthotropic Box Girders**Summary of Items Observed:**

## WELDING INSPECTION REPORT

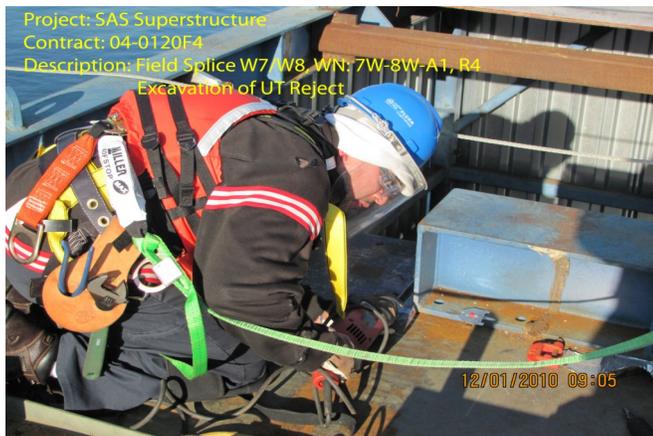
The digital photograph below illustrate the work observed during this scheduled shift.
