DEPARTMENT OF TRANSPORTATION

Quality Assurance and Source Inspection

Contract #: 04-0120F4Cty: SF/ALA Rte: 80 PM: 13.2/13.9File #: 1.28**WELDING INSPECTION REPORT****Resident Engineer:** Siegenthaler, Peter**Address:** 333 Burma Road**City:** Oakland, CA 94607**Report No:** WIR-018437**Date Inspected:** 02-Dec-2010**Project Name:** SAS Superstructure**OSM Arrival Time:** 630**Prime Contractor:** American Bridge/Fluor Enterprises, a JV**OSM Departure Time:** 1500**Contractor:** American Bridge/Fluor Enterprises, a JV**Location:** Job Site**CWI Name:** See Below**CWI Present:** Yes No**Inspected CWI report:** Yes No N/A**Rod Oven in Use:** Yes No N/A**Electrode to specification:** Yes No N/A**Weld Procedures Followed:** Yes No N/A**Qualified Welders:** Yes No N/A**Verified Joint Fit-up:** Yes No N/A**Approved Drawings:** Yes No N/A**Approved WPS:** Yes No N/A**Delayed / Cancelled:** Yes No N/A**Bridge No:** 34-0006**Component:** Orthotropic Box Girders**Summary of Items Observed:**

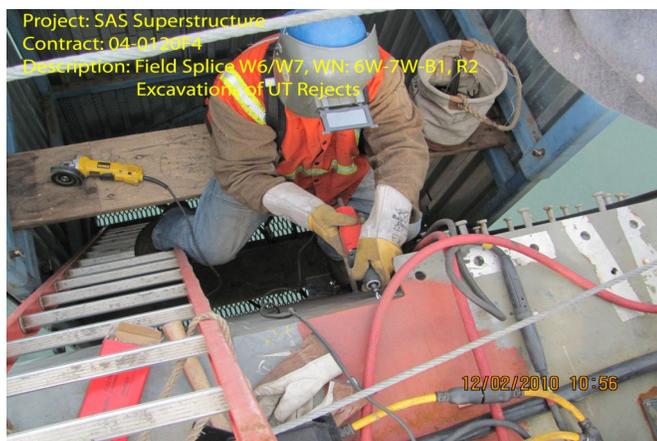
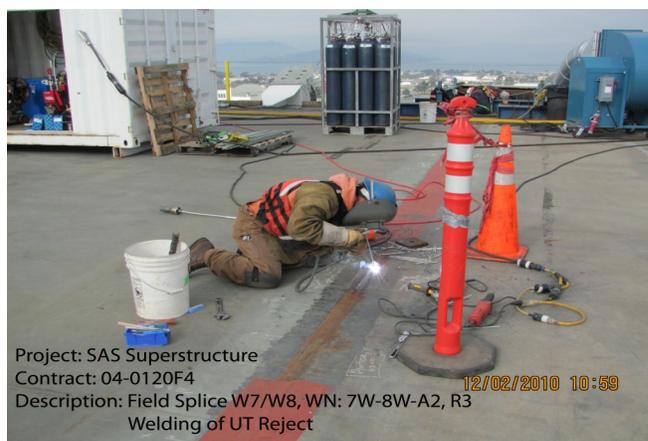
The digital photographs below illustrate the work observed during this scheduled shift.
