**DEPARTMENT OF TRANSPORTATION**

Contract #: 04-0120F4Cty: SF/ALA Rte: 80 PM: 13.2/13.9File #: 1.28**WELDING INSPECTION REPORT****Resident Engineer:** Siegenthaler, Peter**Address:** 333 Burma Road**City:** Oakland, CA 94607**Report No:** WIR-018438**Date Inspected:** 03-Dec-2010**Project Name:** SAS Superstructure**OSM Arrival Time:** 630**Prime Contractor:** American Bridge/Fluor Enterprises, a JV**OSM Departure Time:** 1500**Contractor:** American Bridge/Fluor Enterprises, a JV**Location:** Job Site**CWI Name:** See Below**CWI Present:** Yes No**Inspected CWI report:** Yes No N/A**Rod Oven in Use:** Yes No N/A**Electrode to specification:** Yes No N/A**Weld Procedures Followed:** Yes No N/A**Qualified Welders:** Yes No N/A**Verified Joint Fit-up:** Yes No N/A**Approved Drawings:** Yes No N/A**Approved WPS:** Yes No N/A**Delayed / Cancelled:** Yes No N/A**Bridge No:** 34-0006**Component:** Orthotropic Box Girders**Summary of Items Observed:**

## WELDING INSPECTION REPORT

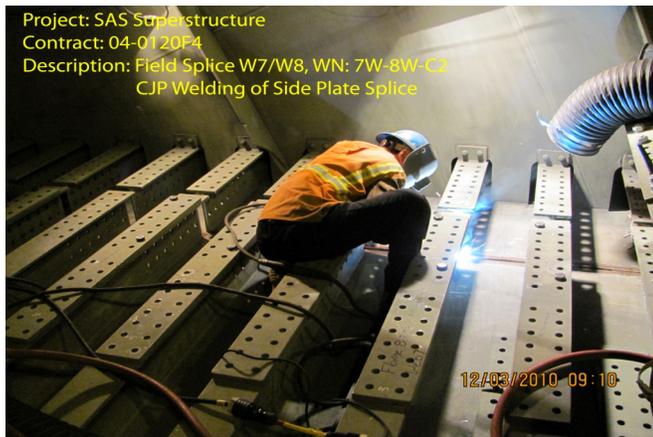
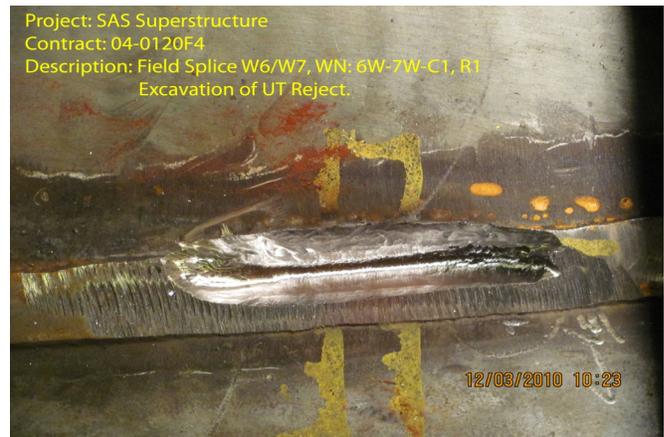
The digital photographs below illustrate the work observed during this scheduled shift.
