Contract #: 04-0120F4Cty: SF/ALA Rte: 80 PM: 13.2/13.9File #: 1.28**WELDING INSPECTION REPORT****Resident Engineer:** Siegenthaler, Peter**Address:** 333 Burma Road**City:** Oakland, CA 94607**Report No:** WIR-018439**Date Inspected:** 01-Dec-2010**Project Name:** SAS Superstructure**OSM Arrival Time:** 630**Prime Contractor:** American Bridge/Fluor Enterprises, a JV**OSM Departure Time:** 1500**Contractor:** American Bridge/Fluor Enterprises, a JV**Location:** Job Site**CWI Name:** Listed below.**CWI Present:** Yes No**Inspected CWI report:** Yes No N/A**Rod Oven in Use:** Yes No N/A**Electrode to specification:** Yes No N/A**Weld Procedures Followed:** Yes No N/A**Qualified Welders:** Yes No N/A**Verified Joint Fit-up:** Yes No N/A**Approved Drawings:** Yes No N/A**Approved WPS:** Yes No N/A**Delayed / Cancelled:** Yes No N/A**Bridge No:** 34-0006**Component:** S.A.S. Components**Summary of Items Observed:**

## 1) OBG Deck Hole Welding

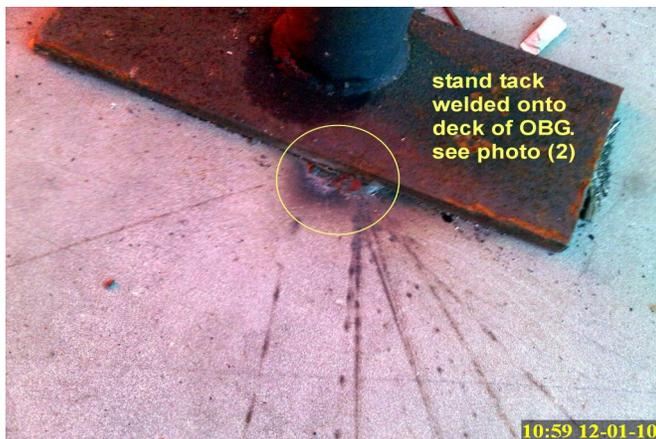
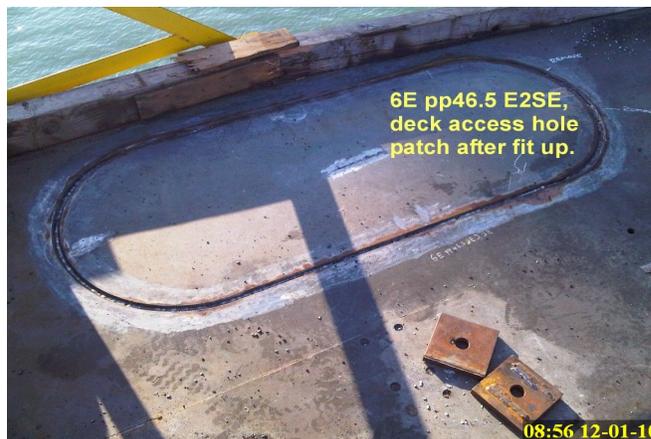
While the QAI was in this area, it was observed that the contractor has tack welded training equipment (welding stands) onto the deck of the permanent structure. The QAI brought this to the attention of the QC Inspector Steve McConnell and asked the QC Inspector if there was any reason why these welding stands would be welded onto the deck. The QC Inspector replied that he was not aware of them being welded. The QC Inspector was shown the stands and asked if he knew who / when these have been welded. The QC Inspector was not able to answer these questions and remarked that anyone could have welded them, including a trainee. The QAI also asked the QC Inspector if it could be determined what electrode could have been used, as there are multiple grades / brands of electrodes present on the job site. The QC Inspector was not able to answer this question. The QC Inspector informed the QAI that these welds will be inspected when the parts are removed but could not specify when that would occur. See the attached photos.
