Contract #: 04-0120F4Cty: SF/ALA Rte: 80 PM: 13.2/13.9File #: 1.28**WELDING INSPECTION REPORT****Resident Engineer:** Siegenthaler, Peter**Address:** 333 Burma Road**City:** Oakland, CA 94607**Report No:** WIR-018441**Date Inspected:** 04-Dec-2010**Project Name:** SAS Superstructure**OSM Arrival Time:** 700**Prime Contractor:** American Bridge/Fluor Enterprises, a JV**OSM Departure Time:** 1100**Contractor:** American Bridge/Fluor Enterprises, a JV**Location:** Job Site**CWI Name:** Mike Johnson and Pat Swain**CWI Present:** Yes No**Inspected CWI report:** Yes No N/A**Rod Oven in Use:** Yes No N/A**Electrode to specification:** Yes No N/A**Weld Procedures Followed:** Yes No N/A**Qualified Welders:** Yes No N/A**Verified Joint Fit-up:** Yes No N/A**Approved Drawings:** Yes No N/A**Approved WPS:** Yes No N/A**Delayed / Cancelled:** Yes No N/A**Bridge No:** 34-0006**Component:** Orthotropic Box Girder**Summary of Items Observed:**

WELDING INSPECTION REPORT

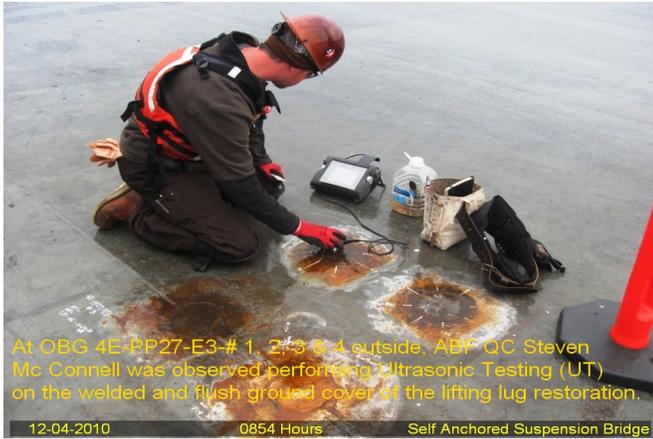
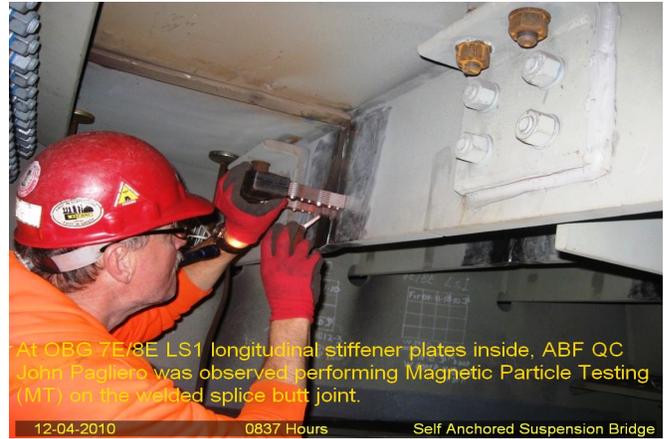
There were five ABF QC that were present at the job site but due to nonappearance of the welders today, some of the QC just did paper works/reports except for John Pagliero who was observed performing Ultrasonic Testing (UT) and Magnetic Particle Testing (MT) at OBG 7E/8E LS1, LS2 and LS3 longitudinal stiffener plate splice butt joints and Steven Mc Connell who was observed performing UT at OBG 4E-PP27-E3-1, 2, 3 & 4 lifting lug access holes restoration.
