DEPARTMENT OF TRANSPORTATION

Contract #: 04-0120F4Cty: SF/ALA Rte: 80 PM: 13.2/13.9File #: 99.28**WELDING INSPECTION REPORT****Resident Engineer:** Siegenthaler, Peter**Address:** 333 Burma Road**City:** Oakland, CA 94607**Report No:** WIR-018447**Date Inspected:** 04-Dec-2010**Project Name:** SAS Superstructure**OSM Arrival Time:** 700**Prime Contractor:** American Bridge/Fluor Enterprises, a JV**OSM Departure Time:** 1900**Contractor:** Zhenhua Port Machinery Company, Ltd (ZPMC)**Location:** Shanghai, China**CWI Name:** Li Yang and Zhu Zhong Hai**CWI Present:** Yes No**Inspected CWI report:** Yes No N/A**Rod Oven in Use:** Yes No N/A**Electrode to specification:** Yes No N/A**Weld Procedures Followed:** Yes No N/A**Qualified Welders:** Yes No N/A**Verified Joint Fit-up:** Yes No N/A**Approved Drawings:** Yes No N/A**Approved WPS:** Yes No N/A**Delayed / Cancelled:** Yes No N/A**Bridge No:** 34-0006**Component:** OBG Trial Assembly**Summary of Items Observed:**

Orthotropic Box Girder (OBG) at Trial Assembly Areas

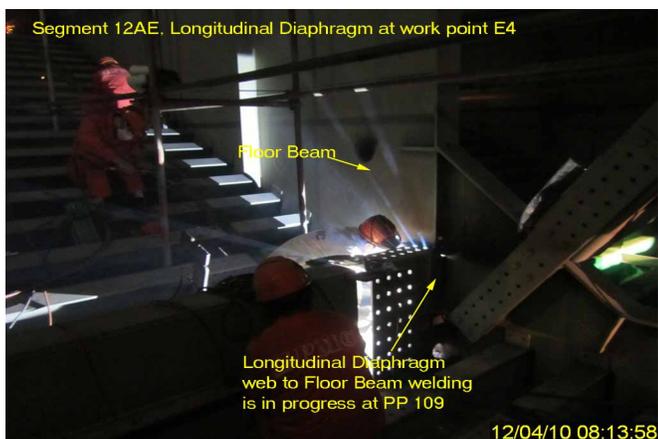
Segment 12AE

This QA Inspector observed the in process fillet welding operation by the Flux Cored Arc Welding (FCAW) process. The weld joint was designated as SP3016-001-033/034. The welder identification was 040367 and was observed welding in the 2F (Horizontal) position using approved Welding Procedure Specification WPS-B-T-2132-ESAB. The piece mark was identified as the Side Panel, T-Ribs hold back weld, Bike Path side.

This QA Inspector observed the in process fillet welding operation by the Shielded Metal Arc Welding (SMAW) process. The weld joint was designated as SP3015-001-001/012. The welder identification was 053871 and was observed welding in the 2F (Horizontal) position using approved Welding Procedure Specification WPS-B-P-2112-FCM-1. The piece mark was identified as the Side Panel, T-Ribs hold back weld, Bike Path side.

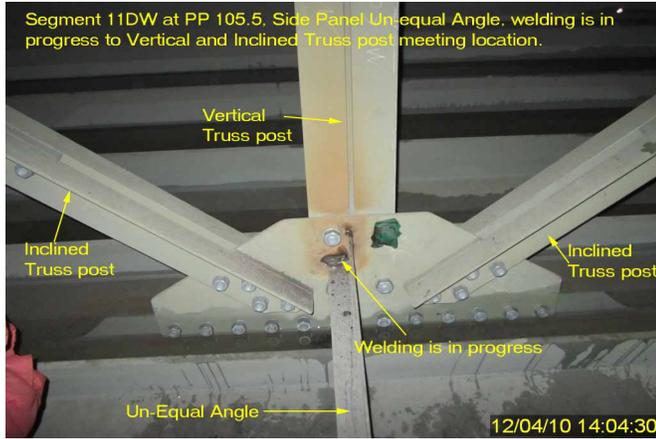
Lift 11 West

This QA Inspector observed Suspender Brackets been removed from it pre-installed locations for further processing. This QA Inspector performed the faying surface gap inspection on December 04, 2010 and observed the gap was within the allowable tolerances. The inspection was performed against the inspection notification # 00018 dated December 04, 2010.
