DEPARTMENT OF TRANSPORTATION

Contract #: 04-0120F4Cty: SF/ALA Rte: 80 PM: 13.2/13.9File #: 1.28**WELDING INSPECTION REPORT****Resident Engineer:** Siegenthaler, Peter**Address:** 333 Burma Road**City:** Oakland, CA 94607**Report No:** WIR-018516**Date Inspected:** 07-Dec-2010**Project Name:** SAS Superstructure**OSM Arrival Time:** 1000**Prime Contractor:** American Bridge/Fluor Enterprises, a JV**OSM Departure Time:** 1830**Contractor:** American Bridge/Fluor Enterprises, a JV**Location:** Job Site

WELDING INSPECTION REPORT

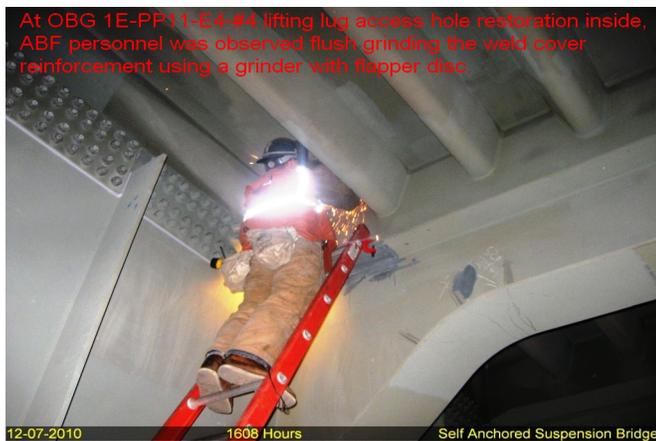
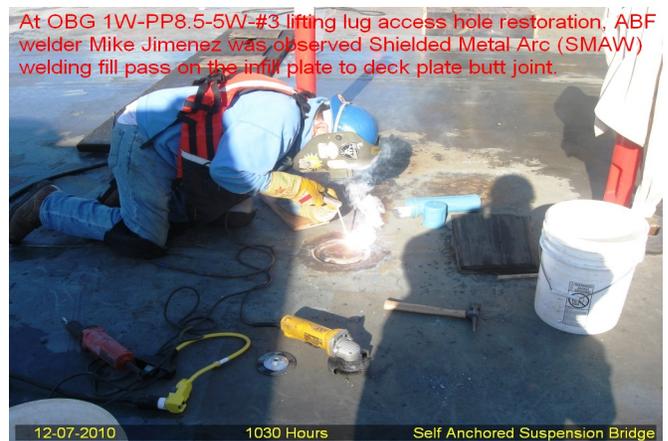
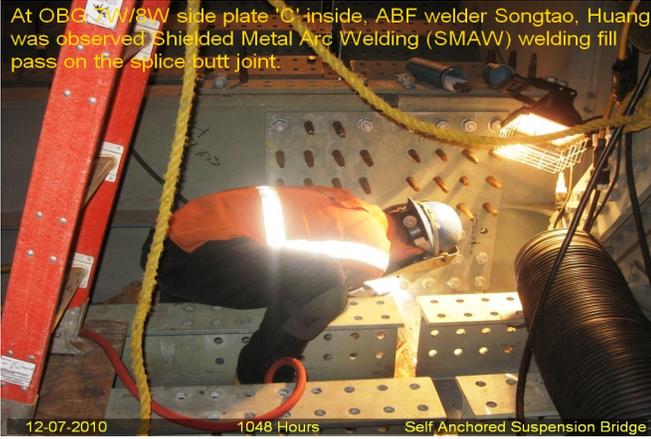
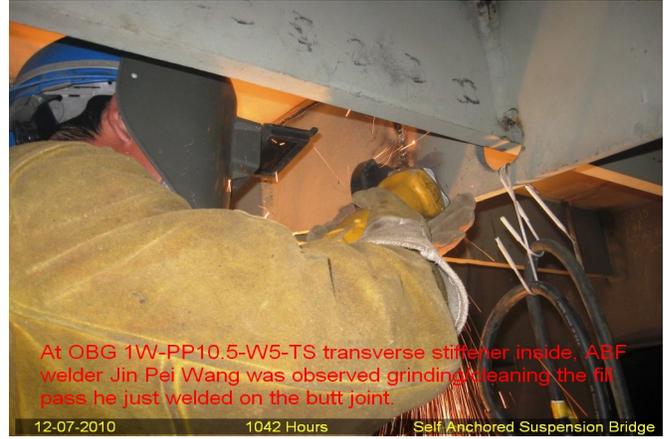
At OBG 1W-PP8.5-W5-#3 & #4 lifting lug access holes infill plate outside, QA randomly observed ABF welder Mike Jimenez perform Shielded Metal Arc Welding (SMAW) welding fill pass on the infill plate to top deck plate butt joint. The welder was noted welding alternately between the two access holes in 1G (flat) position using 1/8" diameter E7018H4R electrode implementing Caltrans approved Welding Procedure Specification (WPS) ABF-WPS-D15-1070. During welding, ABF QC Mike Johnson was noted monitoring the welder's welding parameters. At the end of the shift, fill pass welding on both access holes were still continuing and should remain tomorrow.

At OBG 1W-PP10.5-W5-TS transverse stiffener, QA randomly observed ABF/JV qualified welder Jin Pei Wang manually welding the Complete Joint Penetration (CJP) transverse stiffener splice butt joint. The welder was noted welding fill pass to cover pass in the 3G (vertical) position utilizing a SMAW with 1/8" diameter E7018H4R electrode and implementing Caltrans approved Welding Procedure Specification (WPS) ABF-WPS-D15-1010 Revision 1. The joint being welded has a double V-groove butt joint with open root. During welding, ABF Quality Control (QC) Mike Johnson was noted monitoring the welding parameters of the welder. During the shift, SMAW cover pass welding on both sides of the splice butt joint was completed and the welder has moved to another location and started fitting up the ventilation access hole infill plate to deck plate at OBG 1W-PP10.5-W2-N. At the end of the shift, fit up of the infill plate was still ongoing and should remain tomorrow.

At OBG 2W-PP13.5-W5-S deck access hole infill plate to top deck plate inside, QA noted ABF welder Mick Chan has completed grinding the groove of the gouged area. The welder has called ABF QC Mike Johnson who performed the Magnetic Particle Testing (MT) on the groove of the ground area. After the completion of MT, QA randomly observed ABF/JV qualified welder Mick Chan perform fill pass back welding on the CJP butt joint. The welder was observed manually welding in the 4G (overhead) position utilizing a SMAW with 1/8" diameter E7018H4R electrode and implementing Caltrans approved Welding Procedure Specification (WPS) ABF-WPS-D15-1010 Revision 1. The joint being welded has a double V-groove butt joint first welded with open root from the top deck. ABF Quality Control (QC) Mike Johnson was noted monitoring the welding parameters of the welder. QA randomly monitored the welding parameter with reading of 130 amperes which appears in conformance to the contract requirements. At the end of the shift, SMAW fill pass welding was still continuing and should remain tomorrow.

At OBG 7W/8W side plate inside (9655mm to 10555mm), QA randomly observed ABF/JV qualified welder Songtao, Huang manually welding the CJP splice butt joint. The welder was noted welding in the 3G (vertical) position utilizing a Shielded Metal Arc Welding (SMAW) with 1/8" diameter E7018H4R electrode and implementing Caltrans approved Welding Procedure Specification (WPS) ABF-WPS-D15-1040B. The joint location being welded has a double V-groove butt joint with backing bar with limited access to the Bug-o track mounted FCAW nozzle holder. During welding, ABF Quality Control (QC) William Sherwood was noted monitoring the welding parameters of the welder. During the shift, SMAW cover pass welding on the splice butt joint was still continuing and should remain tomorrow.

At OBG 1E-PP11-E4-#1, 2, 3 & 4 bottom of welded lifting lug restoration, this QA verified the flush grinding/grinding cut orientation and smooth finish verification on these four welded infill plates upon the request of ABF Superintendent Mr. Scott Smith.
