DEPARTMENT OF TRANSPORTATION

Quality Assurance and Source Inspection

Contract #: 04-0120F4Cty: SF/ALA Rte: 80 PM: 13.2/13.9File #: 69.28**WELDING INSPECTION REPORT****Resident Engineer:** Siegenthaler, Peter**Address:** 333 Burma Road**City:** Oakland, CA 94607**Report No:** WIR-018524**Date Inspected:** 02-Dec-2010**Project Name:** SAS Superstructure**OSM Arrival Time:** 700**Prime Contractor:** American Bridge/Fluor Enterprises, a JV**OSM Departure Time:** 1900**Contractor:** Zhenhua Port Machinery Company, Ltd (ZPMC), Changxing Island **Location:** Shanghai, China**CWI Name:** Li Yang**CWI Present:** Yes No**Inspected CWI report:** Yes No N/A**Rod Oven in Use:** Yes No N/A**Electrode to specification:** Yes No N/A**Weld Procedures Followed:** Yes No N/A**Qualified Welders:** Yes No N/A**Verified Joint Fit-up:** Yes No N/A**Approved Drawings:** Yes No N/A**Approved WPS:** Yes No N/A**Delayed / Cancelled:** Yes No N/A**Bridge No:** 34-0006**Component:** OBG Segment**Summary of Items Observed:**

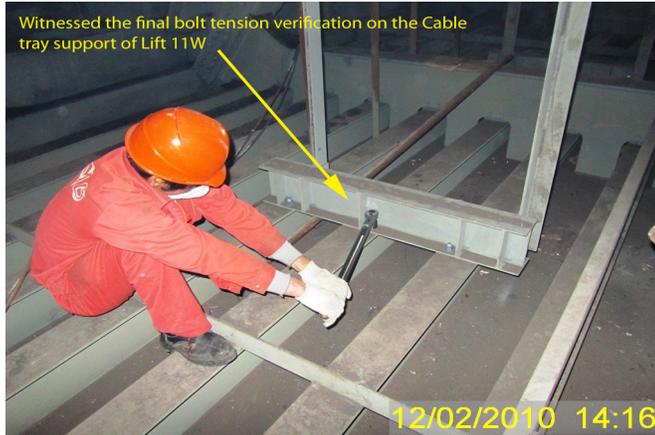
This QA Inspector witnessed the final bolt tension verification on the Catwalk support of Lift 11W. The torque wrench S/N was XO2-114. The QA inspector witnessed 10% of the bolts on a random basis and found the tensioning of the bolts appeared to be in general compliance with the contract specifications. The panel point and bolt size designations were as follows:

This QA Inspector witnessed the final bolt tension verification on the Cable tray support of Lift 11W. The torque wrench S/N was XO2-114. The QA inspector witnessed 10% of the bolts on a random basis and found the tensioning of the bolts appeared to be in general compliance with the contract specifications. The panel point and bolt size designations were as follows:

For additional information please reference the pictures below:
