DEPARTMENT OF TRANSPORTATION

Contract #: 04-0120F4Cty: SF/ALA Rte: 80 PM: 13.2/13.9File #: 69.28**WELDING INSPECTION REPORT****Resident Engineer:** Siegenthaler, Peter**Address:** 333 Burma Road**City:** Oakland, CA 94607**Report No:** WIR-018529**Date Inspected:** 08-Dec-2010**Project Name:** SAS Superstructure**OSM Arrival Time:** 700**Prime Contractor:** American Bridge/Fluor Enterprises, a JV**OSM Departure Time:** 1900**Contractor:** Zhenhua Port Machinery Company, Ltd (ZPMC), Changxing Island **Location:** Shanghai, China**CWI Name:** Li Yang**CWI Present:** Yes No**Inspected CWI report:** Yes No N/A**Rod Oven in Use:** Yes No N/A**Electrode to specification:** Yes No N/A**Weld Procedures Followed:** Yes No N/A**Qualified Welders:** Yes No N/A**Verified Joint Fit-up:** Yes No N/A**Approved Drawings:** Yes No N/A**Approved WPS:** Yes No N/A**Delayed / Cancelled:** Yes No N/A**Bridge No:** 34-0006**Component:** OBG Segment**Summary of Items Observed:**

OBG # TRIAL ASSEMBLY YARD (11EE-12AE)

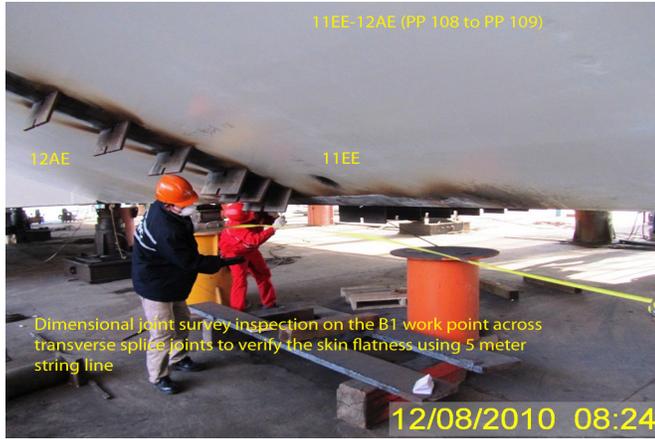
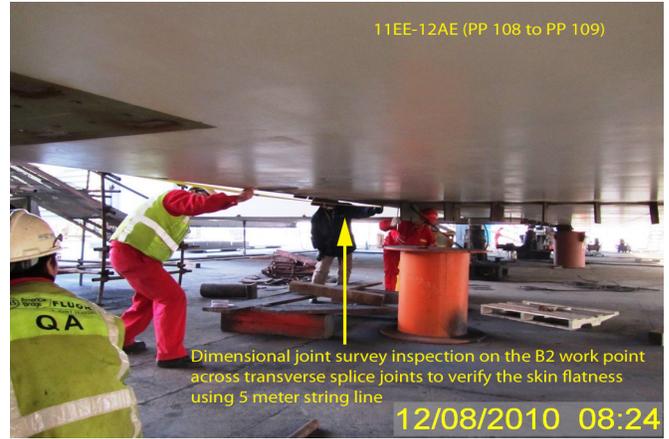
This QA Inspector along with QA Inspector Mr. Manjunath S Math performed dimensional joint survey inspection on the B1, B2, B3, B4, T1 and T2 work point across transverse splice joints to verify the skin flatness using 5 meter string line, 600mm and 630mm straight edge. The measurements were recorded on a separate sheet and forwarded to team leader for review and disposition. The segment and panel point designations were as follows:

Segment 11EE to Segment 12AE – PP 108 to PP 109

For additional information please reference the pictures below:
