**DEPARTMENT OF TRANSPORTATION**

Contract #: 04-0120F4Cty: SF/ALA Rte: 80 PM: 13.2/13.9File #: 69.28**WELDING INSPECTION REPORT****Resident Engineer:** Siegenthaler, Peter**Address:** 333 Burma Road**City:** Oakland, CA 94607**Report No:** WIR-018549**Date Inspected:** 04-Dec-2010**Project Name:** SAS Superstructure**OSM Arrival Time:** 645**Prime Contractor:** American Bridge/Fluor Enterprises, a JV**OSM Departure Time:** 1845**Contractor:** Zhenhua Port Machinery Company, Ltd (ZPMC), Changxing Island **Location:** Shanghai, China**CWI Name:** An Qing Xiang.**CWI Present:** Yes No**Inspected CWI report:** Yes No N/A**Rod Oven in Use:** Yes No N/A**Electrode to specification:** Yes No N/A**Weld Procedures Followed:** Yes No N/A**Qualified Welders:** Yes No N/A**Verified Joint Fit-up:** Yes No N/A**Approved Drawings:** Yes No N/A**Approved WPS:** Yes No N/A**Delayed / Cancelled:** Yes No N/A**Bridge No:** 34-0006**Component:** Orthotropic Box Girder (OBG)**Summary of Items Observed:**

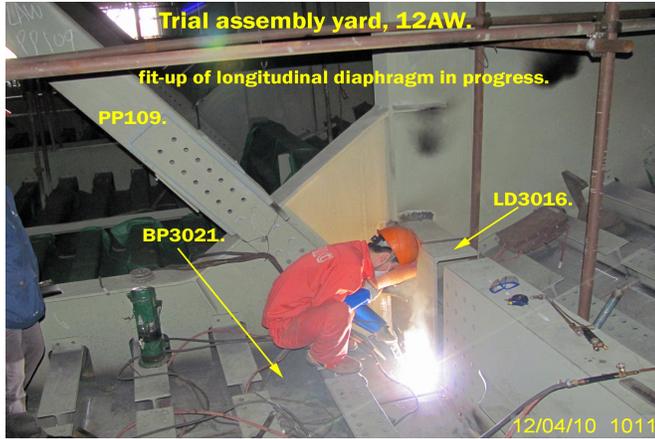
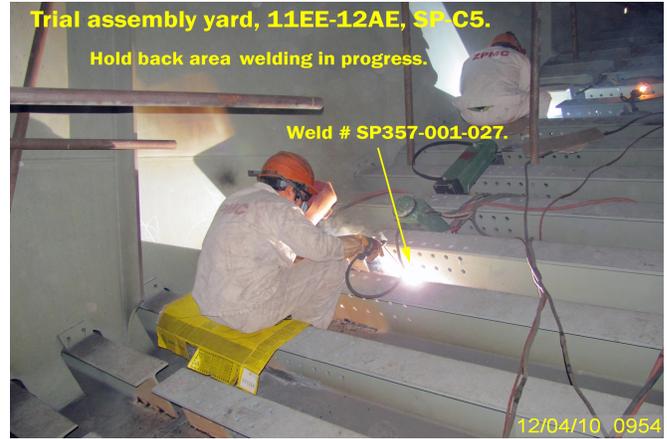
During Random Visual in-process Inspection, this QA inspector observed fit-up of longitudinal diaphragm at intersection of OBG segment 11EE-11AE. Welder observed tack welding using Shielded metal arc welding (SMAW). Welder is identified as 218707; ZPMC Quality Control Inspector (QC) is identified as Zhu Yuan Yuan. The welding variables recorded by Quality Control Inspector (QC) appeared to comply with the Applicable WPS: WPS-B-P-2112-FCM-1. The attached photographs provide additional detail.
