**DEPARTMENT OF TRANSPORTATION**

Contract #: 04-0120F4Cty: SF/ALA Rte: 80 PM: 13.2/13.9File #: 1.28**WELDING INSPECTION REPORT****Resident Engineer:** Siegenthaler, Peter**Address:** 333 Burma Road**City:** Oakland, CA 94607**Report No:** WIR-018567**Date Inspected:** 07-Dec-2010**Project Name:** SAS Superstructure**OSM Arrival Time:** 630**Prime Contractor:** American Bridge/Fluor Enterprises, a JV**OSM Departure Time:** 1500**Contractor:** American Bridge/Fluor Enterprises, a JV**Location:** Job Site**CWI Name:** Listed below.**CWI Present:** Yes No**Inspected CWI report:** Yes No N/A**Rod Oven in Use:** Yes No N/A**Electrode to specification:** Yes No N/A**Weld Procedures Followed:** Yes No N/A**Qualified Welders:** Yes No N/A**Verified Joint Fit-up:** Yes No N/A**Approved Drawings:** Yes No N/A**Approved WPS:** Yes No N/A**Delayed / Cancelled:** Yes No N/A**Bridge No:** 34-0006**Component:** S.A.S. Components**Summary of Items Observed:**

## 1) OBG Deck Hole Welding

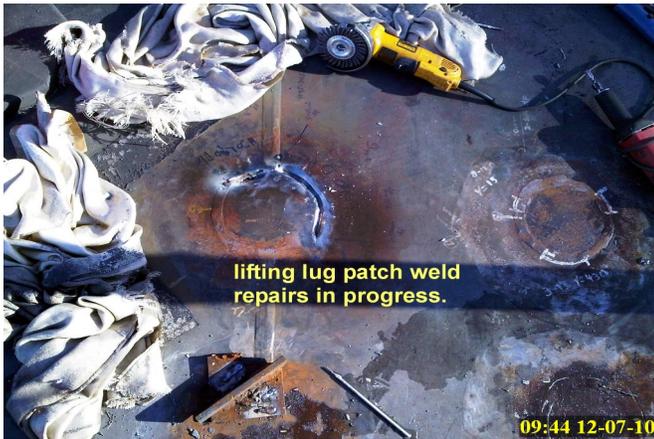
The QAI observed repairs being made in lifting lug patch welds at PP27 E3 #3. The QAI noted that the repairs

were identified by Ultrasonic Testing (UT) that was performed by the QC Inspectors. The QAI noted that the QC Inspector Pat Swain is monitoring the repairs being made by Early Espinoza, ID 5824. The QAI was informed that several rejectable indications have been grouped into 2 general excavations of weld. The QAI also noted that other lifting lug patches at this location have been identified for repairs. See the attached photo.

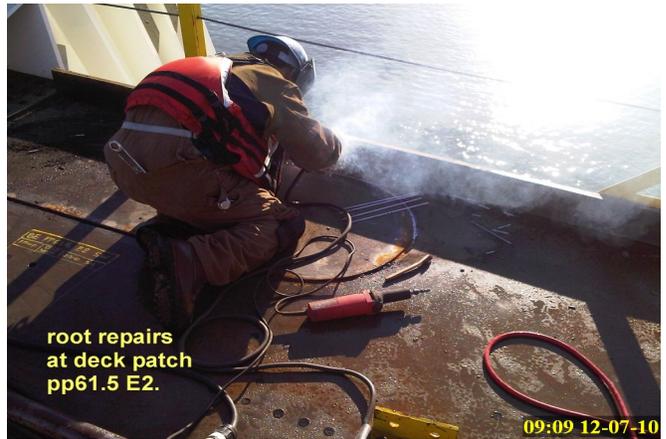
The QAI made observations of welding on deck access hole patch at PP61.5-E2SE. The QAI observed Mick Chan, ID 9265, using SMAW to make the root welds. The QAI noted that the QC Inspector Steve McConnell is monitoring this work. The QAI was informed that additional welding was required from the top and that during the back gouging the root was removed in several locations. The QAI noted that the weld joint had several holes that were being filled in. See the attached photo.
