DEPARTMENT OF TRANSPORTATION

Contract #: 04-0120F4Cty: SF/ALA Rte: 80 PM: 13.2/13.9File #: 1.28**WELDING INSPECTION REPORT****Resident Engineer:** Siegenthaler, Peter**Address:** 333 Burma Road**City:** Oakland, CA 94607**Report No:** WIR-018572**Date Inspected:** 09-Dec-2010**Project Name:** SAS Superstructure**OSM Arrival Time:** 630**Prime Contractor:** American Bridge/Fluor Enterprises, a JV**OSM Departure Time:** 1500**Contractor:** American Bridge/Fluor Enterprises, a JV**Location:** Job Site**CWI Name:** See Below**CWI Present:** Yes No**Inspected CWI report:** Yes No N/A**Rod Oven in Use:** Yes No N/A**Electrode to specification:** Yes No N/A**Weld Procedures Followed:** Yes No N/A**Qualified Welders:** Yes No N/A**Verified Joint Fit-up:** Yes No N/A**Approved Drawings:** Yes No N/A**Approved WPS:** Yes No N/A**Delayed / Cancelled:** Yes No N/A**Bridge No:** 34-0006**Component:** Orthotropic Box Girders**Summary of Items Observed:**

WELDING INSPECTION REPORT

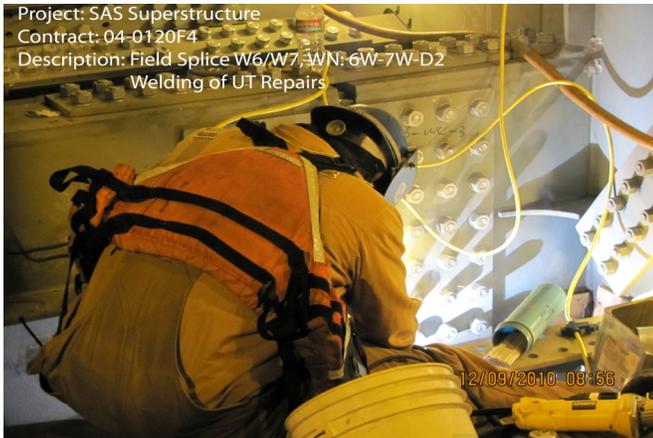
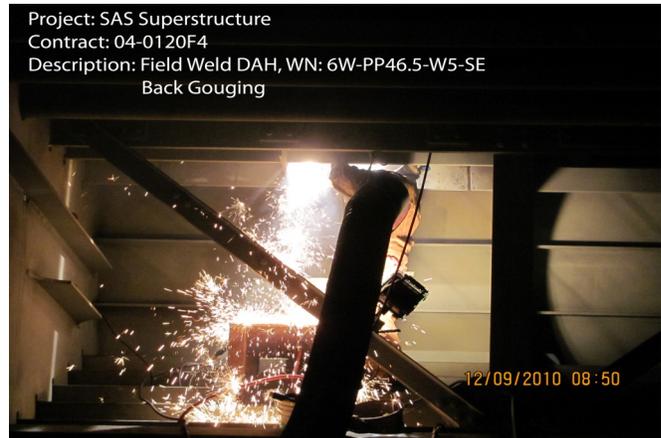
The digital photographs on page 4 of this report illustrate the work observed during this scheduled shift.
